Gas oven explosion

April, 1st, 2003

Geleen

THE INSTALLATIONS IN QUESTION

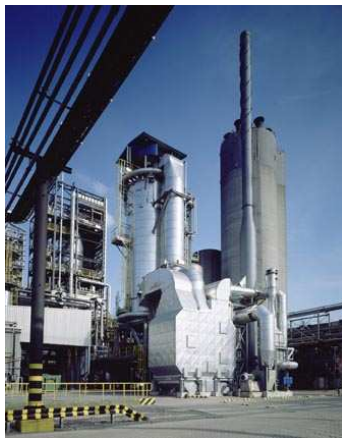
The explosion caused the lid of the oven, on which a maintenance crew was working, to be blown off. The lid fell down in the oven, together with the crew who were standing on it.
