FIREWORKS ACCIDENT ANALYSIS

I Accident statistics at a glance	3
II Production	5
III Storage	6
IV Transport	7
V Destruction	8
VI Use by consumers	9
General recommendations	10
Bibliography	11
Selection of French accidents quoted in the text	12

The present summary relies on an analysis of 316 accidents (102 in France, 214 elsewhere), as extracted from the ARIA¹ accident database and primarily involving classified facilities or potentially classified sites, in addition to a few selected cases, whose lessons are easily transposable (e.g. accidents involving black powder). In light of the available data and specificities of some of the events related to the fireworks themselves (e.g. accidents during use by the general public) but not necessarily input into the database, this summary is not intended to provide statistical analyses, but instead the basis for drawing lessons on risks inherent in these products during manufacturing, storage, use and disposal.

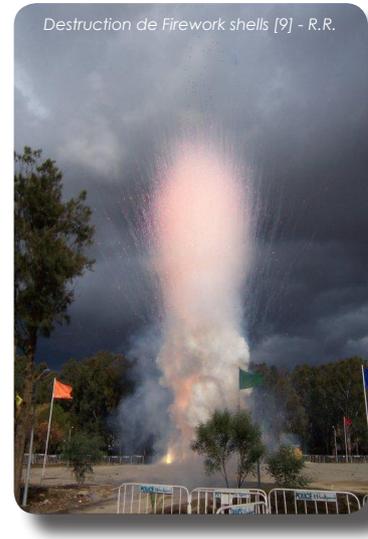
With regards to accident analysis in this field, the reader is referred to the study entitled «**Destruction of pyrotechnic wastes: Accident analysis**», published by BARPI in 2010 [11]. Many lessons and recommendations can be directly transposed to destruction steps involving fireworks, notably a more comprehensive knowledge of the wastes to be destroyed and their associated risks (ARIA [14565](#), [19145](#) - unfamiliarity with the risks and mixing of incompatible products, causing fire during the unloading of fireworks scheduled for disposal; 22518 - reaction of a photogenic compound in storage for 20 years), a limitation of the quantities suitable for simultaneous destruction (ARIA [14565](#), [19132](#) and [36349](#) - deflagration during fireworks destruction), and technician protection (ARIA [19145](#), [24915](#) - flash experienced during the destruction of firework shells).

Destruction de Firework shells [9] - R.R.
