WHEN NATURAL AND TECHNOLOGICAL
HAZARDS COLLIDE

**OVERVIEW OF THE INDUSTRIAL ACCIDENTS
CAUSED BY THE GREAT TOHOKU
EARTHQUAKE AND TSUNAMI**

JAPAN, MARCH 11th, 2011

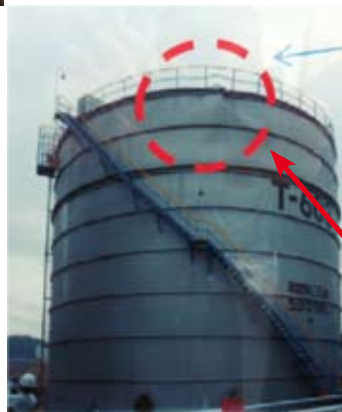
Storage tank foundation buckled by liquefaction in the Niigata oil terminal
(Source : NRFID)
