# Untimely injection of foam into a warehouse containing phytosanitary products

30 April 2012

**Ludres (Meurthe-et-Moselle)  
France**

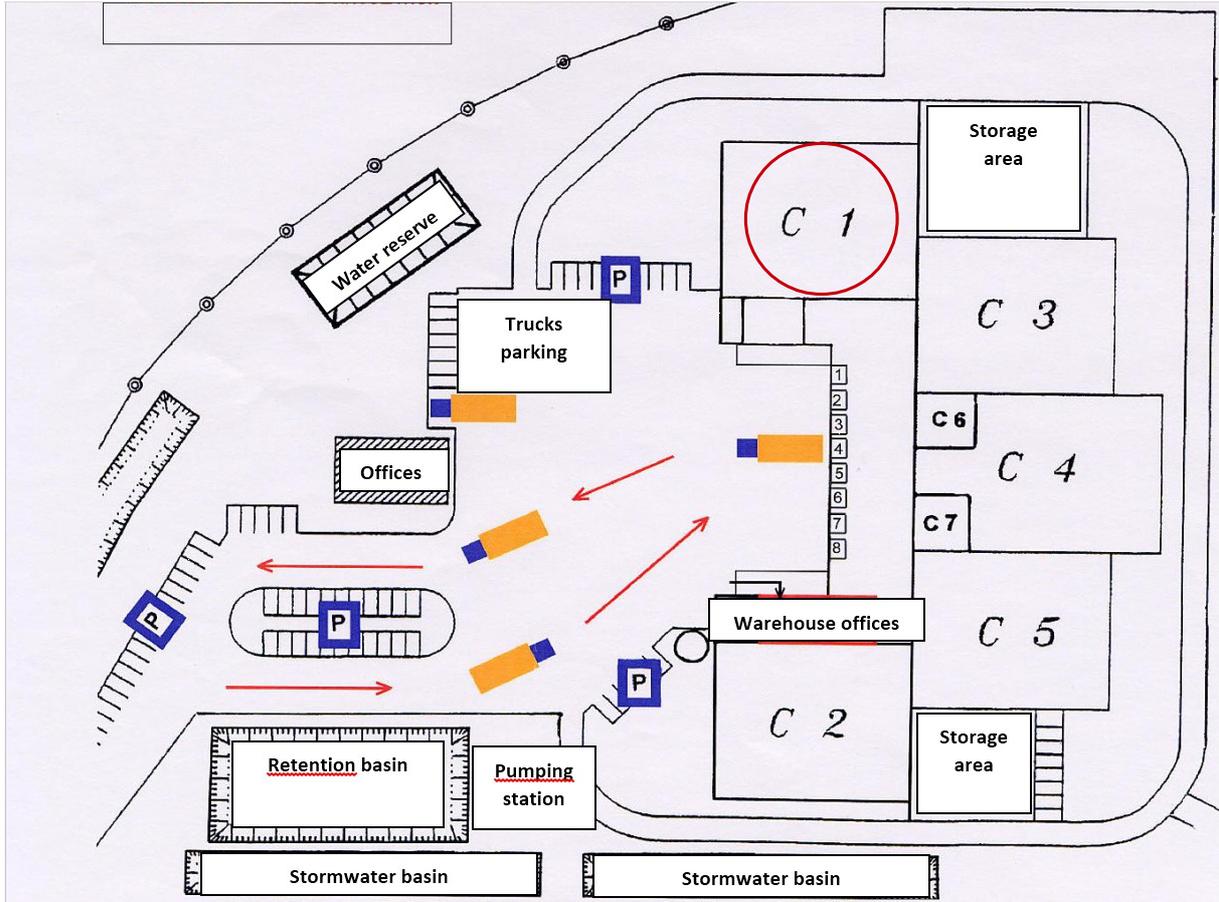
Figure 1 : Layout of the logistics platform (ARR)

The warehouse is composed of 7 storage cells ranging from 60 to 1250 m<sup>2</sup> with a 10 m height (3 m for the 60 sq. m<sup>2</sup> cells), each one of which is assigned to specific hazardous substances (see Fig. 1). The cell walls have a fire resistance rating of 120 minutes. Cell doors have been fitted with automatic closing devices, while the cells themselves are protected against fire by means of an automatic extinction system that relies on foam flooding.

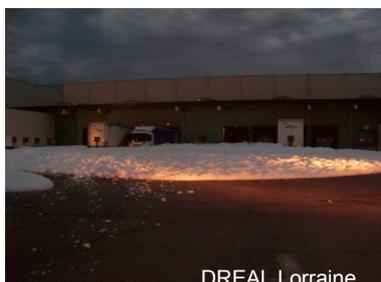
Figure 5 : Path followed by the three fire-fighter investigation team (ARR)

The two surviving fire-fighters of the three-man reconnaissance team, as well as the members of subsequent investigation parties, reported that the foam inside the buildings did not display the same consistency as that observed outside. They all complained of real difficulty in advancing into the foam, which entailed coping with a highly viscous substance that constrained any kind of movement. They also expressed that the foam had been an obstacle to vision, to such an extent that a hand placed in front of the eyes remained invisible. Similarly, the foam acted as sound insulation, thus preventing verbal exchanges (besides radio) with the other two fire-fighters in the trio. In addition, they mentioned that shortly before exiting the premises, the foam wound up penetrating inside their breathing masks. The team's progress had been slowed to a point that they were not even able to enter Cell 1 and had to turn around barely after reaching the door (red dot in Fig. 5).

Following the enquiry, emergency services concluded that the foam viscosity had caused both excess oxygen consumption and the formation of a film on the relief valve appended to the mask. This film in turn raised the valve's opening pressure, thus building up pressure inside the breathing mask and causing the appearance of empty spaces between the responders' faces and masks.
