# Pneumatic explosion during an intervention on a pipe at a pyrotechnic plant

30 July 2014

Pont de Buis (Finistère)

Pyrotechnics  
Pneumatic explosion  
Organisation /  
Procedures

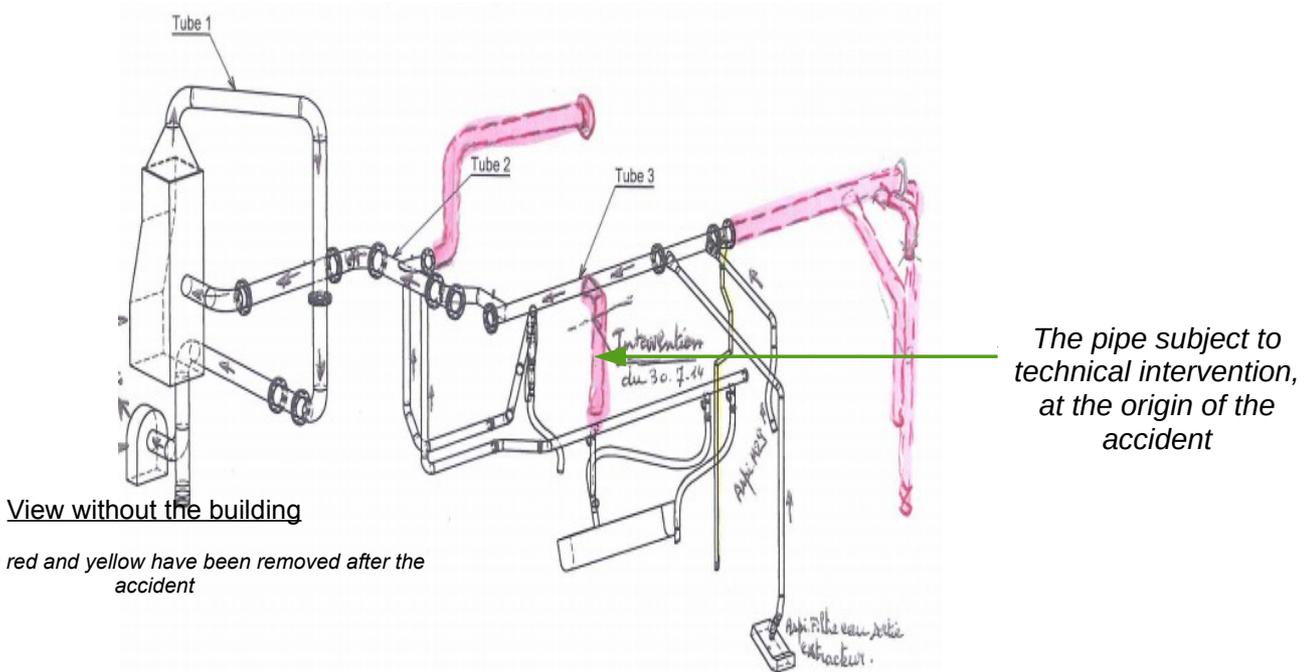
The accident occurred inside the "extractor" room located on the ground floor of the production workshop. This room was equipped with machinery for extracting the solvents contained in the powders output by the double-screw extruder operating on the floor above. This extraction entailed washing with hot water circulating upstream in a worm gear. The solvent-laden water recovered was then channelled to a distillation unit for solvent regeneration. In conjunction with this step, the air filled with volatile organic compounds (VOC) was also collected by a suction network for distillation treatment prior to discharge. This network wound up at the origin of the accident.
