# Collapse of the dam of a tailings pond

25 April 1998

**Aznalcollar**

**Spain**

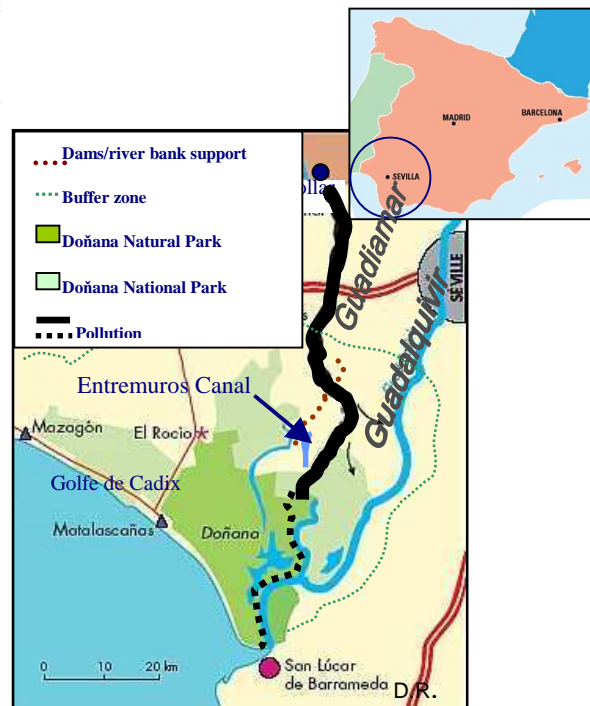
- The waste from the process that represents 90 % of the ore treated is emptied into a pond. After decantation, the supernatant liquid is pumped and reused in the process. The liquid is highly acidic (pH<3) and rich in zinc (450 mg/l), copper (17 mg/l) and lead (3.5 mg/l), and contains significant amounts of arsenic (0.2 mg/l).

*Pollution pathway*

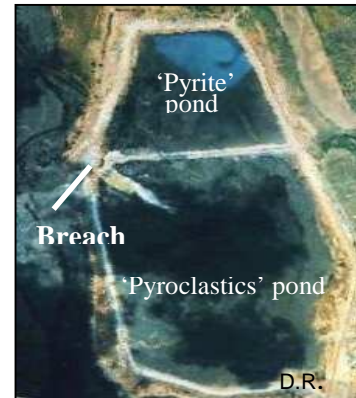
➤ This **2 km by 1 km artificial double basin** with a 32.6 million m<sup>3</sup> capacity was built in 1976 when the old mine was set up. It is surrounded by a 30 m high **dam** whose height is regularly increased using the material derived from mining activity.

➤ The dam sits on a 4 m thick layer of alluvial gravel that in turn overlies a 70 m layer of blue marl, a sedimentary rock containing lime, and clay in approximately equal proportions.

*Satellite sight of the basins of storage*

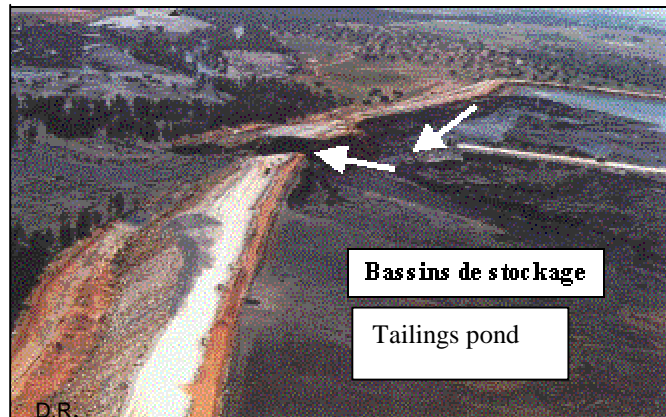
- The accident took place in 3 phases:
  - the separation barrier cracked when a 30mX20mX14m alluvial and marl plate located at the junction of the two tailings ponds slid over 1m, **1**
  - the supernatant waste in the 'pyrite' pond infiltrated the crack. The increased pressure on the peripheral dam along with a decrease in the resistance of its foundation accentuated the original sliding phenomena causing the main dam to slide up to 60m sideways, its deflection at 2-3m,, several cracks and spillage of waste, **3**
  - the waste flooded below the dam**4**, that collapsed at a 50m section releasing the sludge and acid water.

- Design and construction flaws,
- Degradation of the clayey subsoil exposed to acidic waste and further strained due to the high pressure resulting from the water and sludge,
- overfilling of the tailings ponds
