Explosion inside a pyrotechnic plant

August 7, 1975

Pont de buis les Quimerch [29]

France

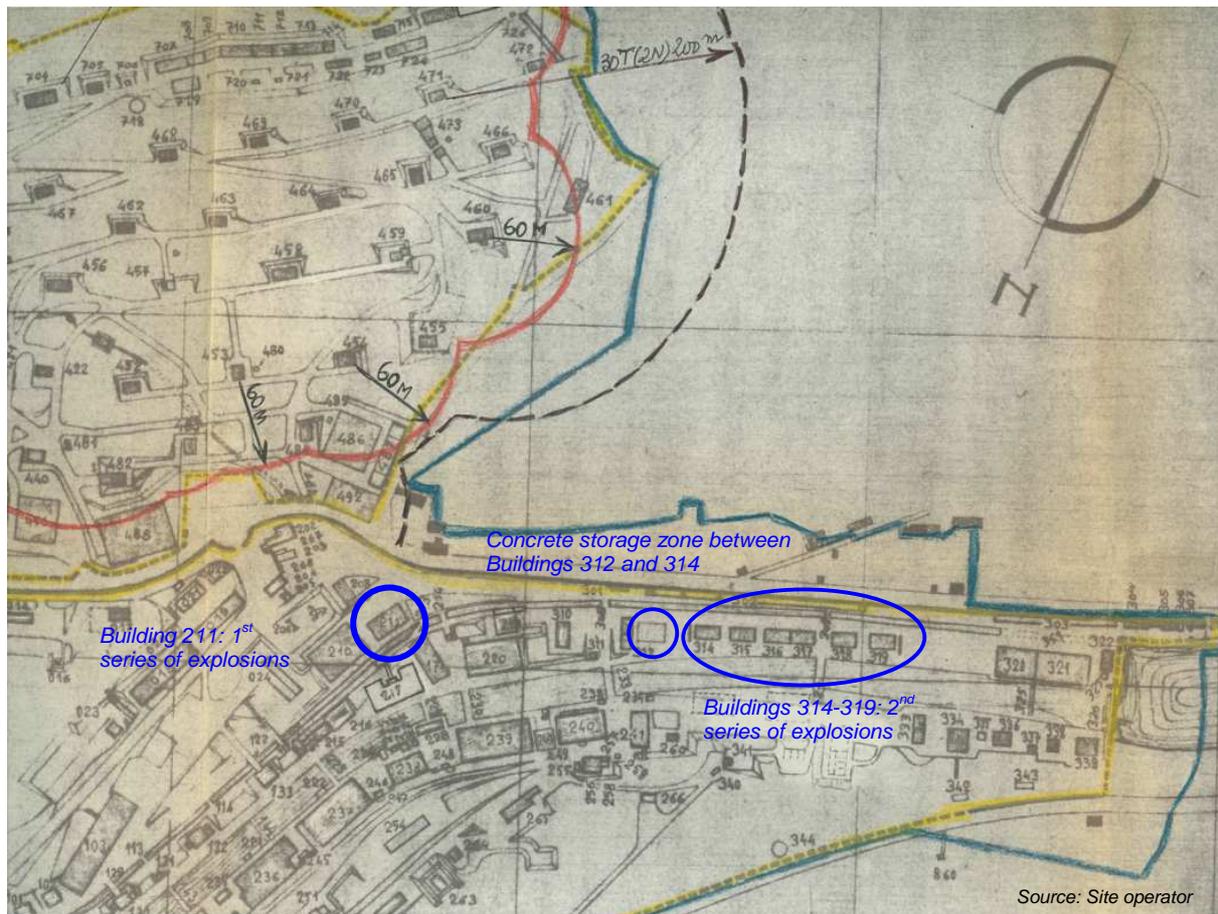
Buildings 314 through 319 housed the dryers and were located between the river crossing the site and an outdoor storage zone built on a concrete slab that extended between buildings 312 and 314 (see picture below). The dryers were of a conventional type with 4 shield units per building; each unit received 1 box, and the heating installation was shared by 2 units.
