## Explosion in a dynamite manufacturing plant

March 3, 1988

**Ablon – [Basse – Normandie]  
France**

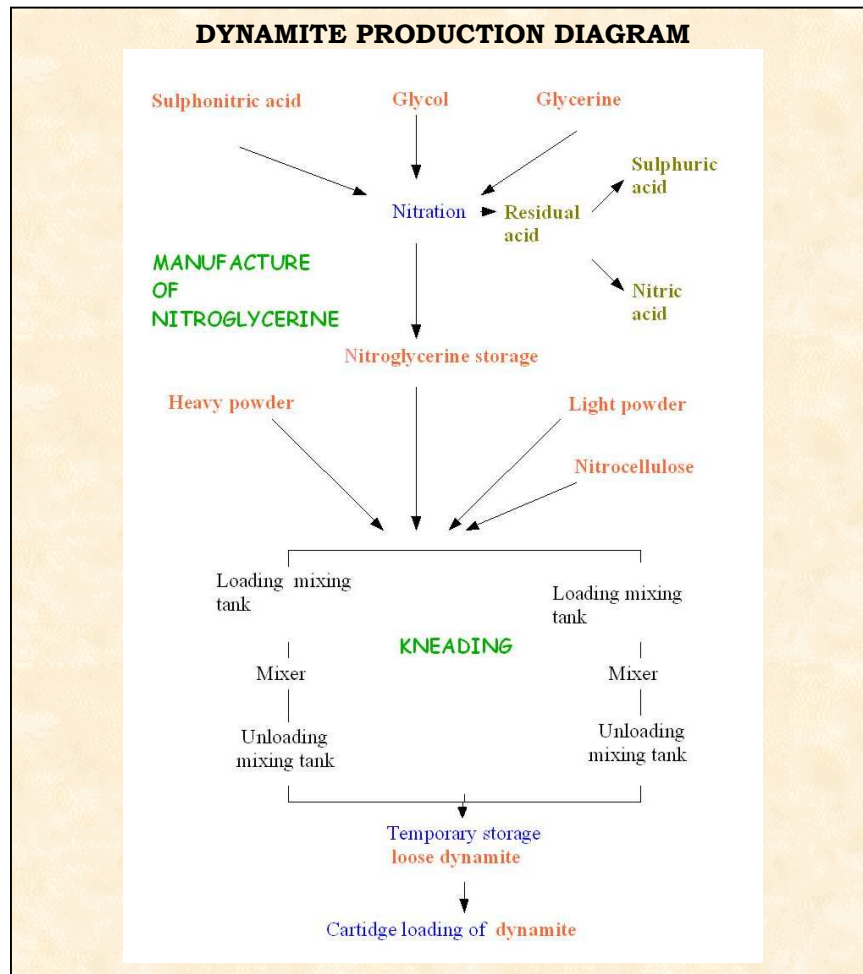
The manufacturing operation consists of a series of steps performed in several workshops:

- loading of dynamite ingredients (nitrolycerin, nitrocellulose...) in workshop P10 into a mixing tank in order to synthesise 300 kg of dynamite,
- manual transport from the loaded tank to the mixing workshop P11,
- mixing in workshop P11,
- transfer of the full tank of dynamite to the unloading workshop E44,
- unloading of the tank into plastic recipients (20 kg of dynamite) and loading these containers using an industrial truck (300 kg of dynamite),
- the truck is taken to a buffer storage workshop,
- transport from this workshop to the cartridge loading warehouse E30,
- cartridge loading and packing into cases in E30,
- transport of cases to E20,
- closing of cases in E20,
- transport of the cases of dynamite to the storage depots.
