Rupture of a phosphoric acid storage tank

23rd April 1999

Rouen (Seine Maritime)

France

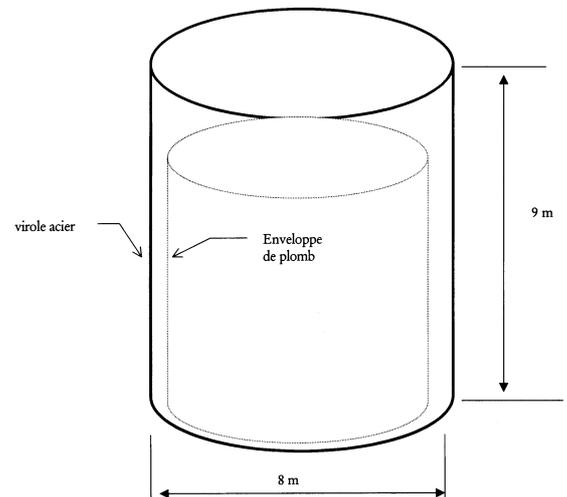
The tank was made of a steel casing lined with lead sheeting to ensure a hermetic seal in relation to the structural casing. This tank, measuring 9 meters high by 8 meters in diameter, was correctly dimensioned to contain phosphoric acid at atmospheric pressure. The retaining basin consisted of a slab (thickness: 15cm) and retaining walls (thickness: 15cm at the base, 10cm at the top). The entire structure was made of reinforced concrete. The mechanical resistance at the slab-wall intersection was ensured by two metal brackets made of 10mm steel round stock placed every 20 centimetres.

On that friday afternoon, the casing of the tank suddenly ripped. The violent release of the acid caused the concrete retaining basin to rupture. Traces left of an adjoining wall show that the wave was several meters high. Most of the acid spread over the ground and in the bulk fertilizer warehouses.

Significant corrosion was noted at the foundation skirt junction level; a symmetrical opening of the foundation skirt junction in relation to the cylinder's corroded generatrix.

There was a failure in the seal which initially occurred on the internal casing at the level of the 4th ring of the structural casing. As both casings were not bonded, the acid leak was routed vertically causing the corrosion along a generatrix and then along the foundation skirt junction. The repair carried out by the maintenance department did not correct the weak point between rings 2 and 4 of the cylinder.

Furthermore, the pressure exerted by the acid is far greater than that exerted by the water during the resistance test (1,640 kg/m³ for phosphoric acid). The rupture occurred suddenly and the wave effect created pressure on the retaining walls must be greater than the hydrostatic pressure. In addition, defects were discovered in the concrete reinforcement: the reinforcement bars were not correctly attached.
