## Accident on a cooling box of a feed chute of a furnace in a refuse incineration plant

22 July 1999

Saint Ouen [93]

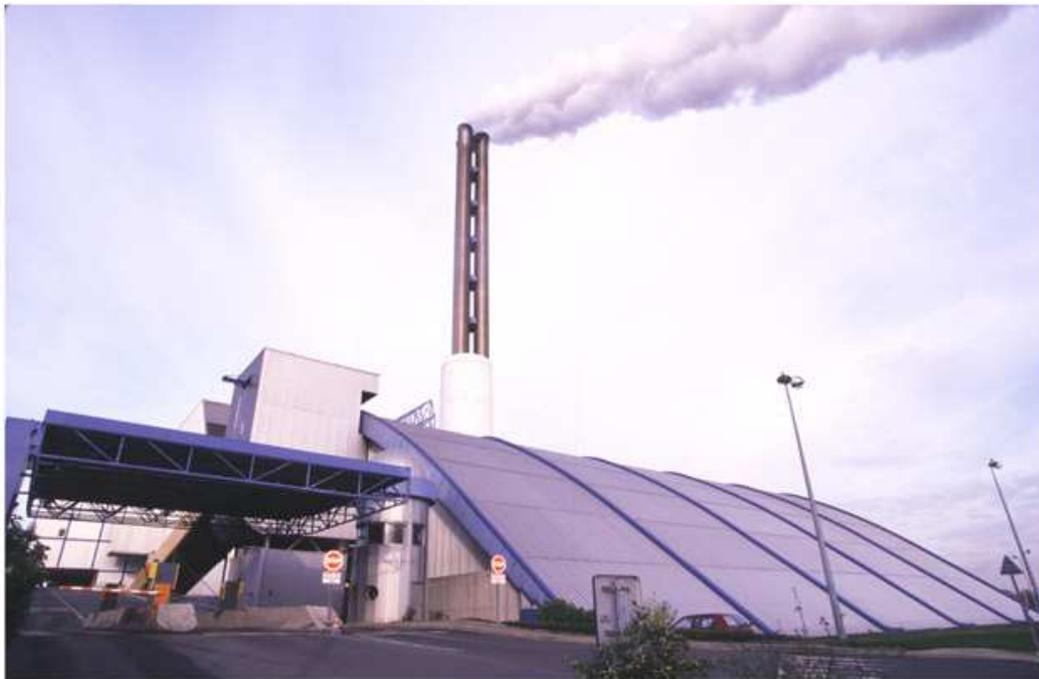
The lower part of each feed chute of the furnaces must be cooled to avoid heating and deterioration of metal plates exposed to thermal radiation from the furnace (temperature of 1000 °C). A "water jacket" system comprising 20 2.5m long cooling boxes containing water flowing at a pressure of 3 bar between the plates (8 and 16 mm thick) is used for cooling. The waterway is fitted with valves at the inlet and outlet of each cooling box divided into four compartments by three baffle plates.

The facility was re-commissioned on 8 July and was reported by the operator to have functioned normally without any malfunctions until the accident. The explosion took place at the level of the concrete-filled cooling box that was severely damaged, the outer plate was ripped out and the inner plate bent towards the furnace, indicating that the explosion actually occurred in the cooling box where the valve was closed. A closer observation revealed that the inner plate was also ripped apart and the flames from the furnace inflicted serious burns on the technician. According to the initial analysis the explosion is undoubtedly due to an abrupt vaporisation of water in a closed space.
