## VCM leak in a chemical plant

25th August 1999

Tavaux (Jura)

VCM  
Organisation /  
Procedure  
Human / control flaw  
Autoclave

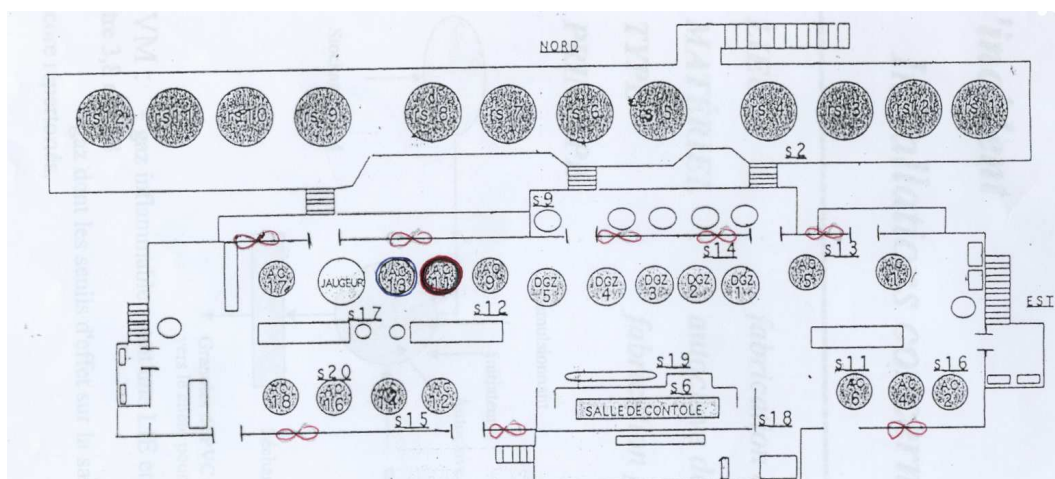
The installation concerned by the accident is the PVC manufacturing facility, itself including 3 workshops. Workshop P69 corresponds to the polymerisation of PVC by a "suspension" process. In order to better understand the progression of the accident, this process is detailed below.

Production is carried out in a discontinuous manner, by "batch", with the reaction taking place in dual-casing autoclaves (a stainless steel tank and steel casing) having a volume of 27.5m<sup>3</sup>. The shop includes 13 autoclaves. The reaction takes place under a pressure of 6 to 9 bar and at a temperature from 40 to 70°C.
