Toxic gas cloud emanating from a TiO₂ ore treatment plant

September 3rd and November 9th, 1999

Calais (Pas-de-Calais)

- Electrical failure
- Sulphur oxides
- Organisation / deficient process controls
- Check valve
- Automated device
- Washing tower
- Self-sustaining reaction

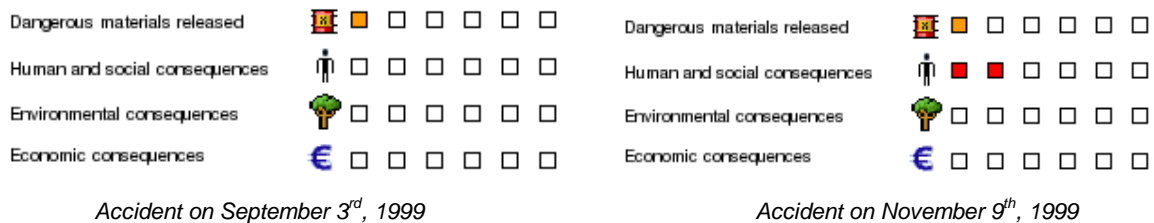
By applying the rating rules applicable to the 18 parameters of the scale officially adopted in February 1994 by the Member States' Competent Authority Committee for implementing the 'SEVESO' Directive on handling hazardous substances, and in light of information available, this accident can be characterised by the four following indices:

A total 600 kg of gas (SO₂, SO₃) were released during each accident. Considering that the plume contained 100% sulphur trioxide, whose SEVESO threshold equals 75 tons, the Q1 parameter remained below 0.1% of the SEVESO threshold; consequently, the overall level of the "hazardous materials released" index reached 1 in each accident.
