Rupture of a liquid fuel pipeline

July 28, 1989

Rosteig - [Bas-Rhin]

Explosion
Fire
UVCE
Piping / pipeline
Naphtha
Building works
(subcontracting)
Victims

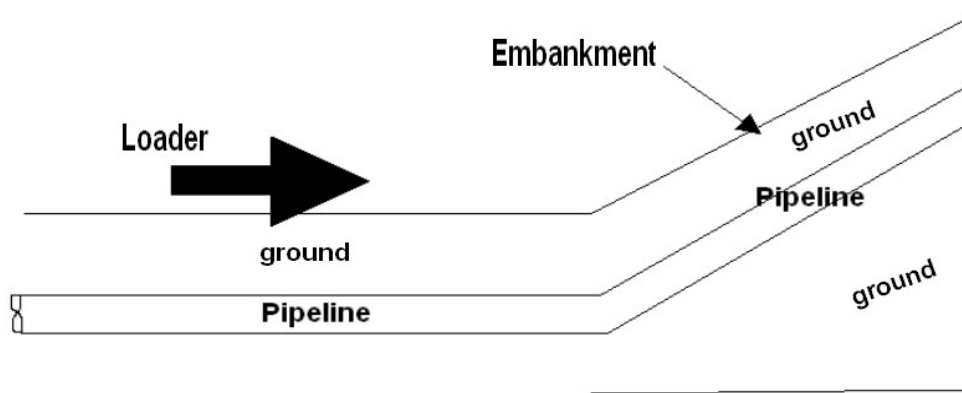
At 9:55 am, within the municipality of Rosteig, the bucket on a loader struck and punctured the Sarre oil pipeline while performing earthworks for a horizontal platform on an adjoining privately-owned parcel.

At the point of impact (elevation: 271.7 m), the loader was extracting ground materials from an embankment with a 15% slope, in which the punctured pipeline had been buried at an average depth of 1.2 m.
