Fire on an elastomer storage site

January 20, 2000

Clermont-Ferrand (63)

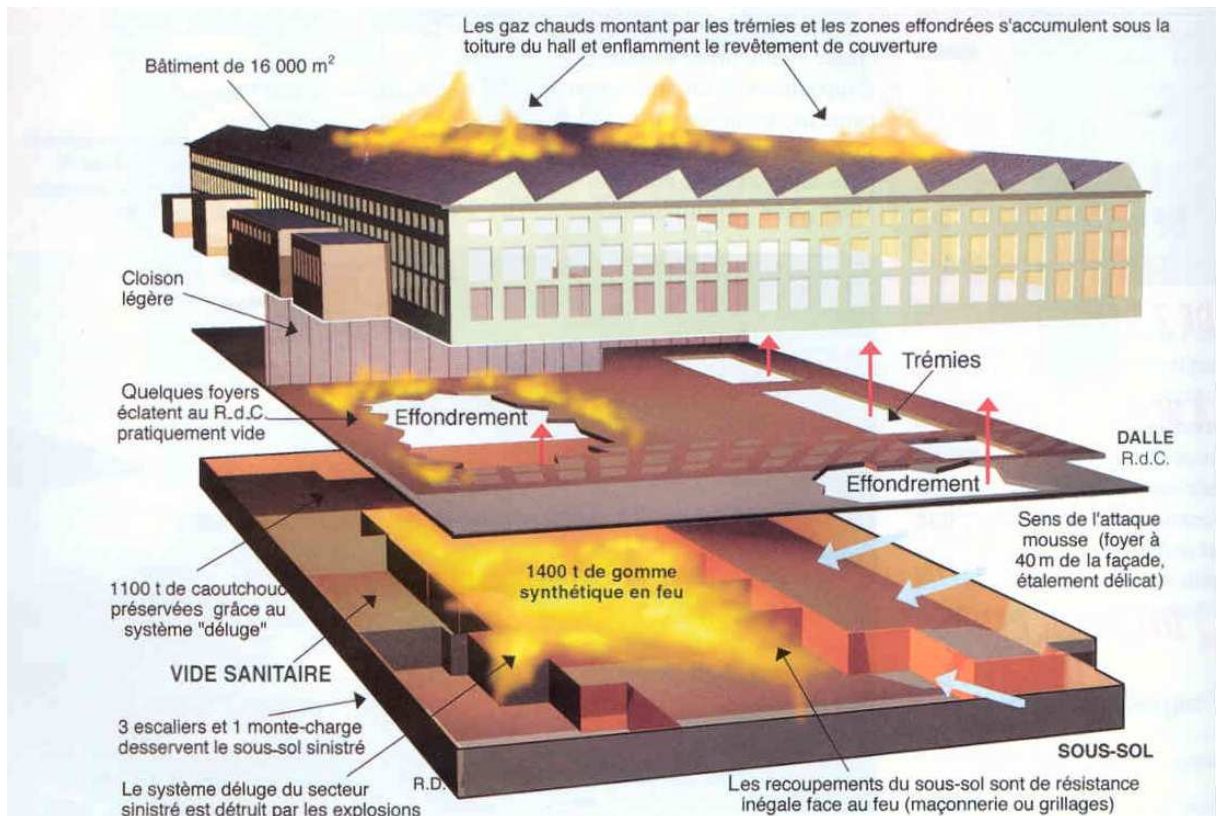
21h30: reinforcement firemen were requested from neighbouring districts. Nearly 500 firemen were involved in all with a maximum of 130 in simultaneous operation. The gum continued to burn until the evening of Friday 21st January when its intensity diminished visibly around 19 h.

Illustration by René Dosne (Face au Risque n° 364 June-July 2000)
