## Water pollution from a cyanide spill in Eastern Europe

January 30, 2000

**Baia Mare**  
**Romania**

Subsequent to the failure of a storage basin dyke on January 30, 2000, 300,000 m<sup>3</sup> of cyanide-laced effluent destroyed all of the flora and fauna over more than 600 km of river habitat.

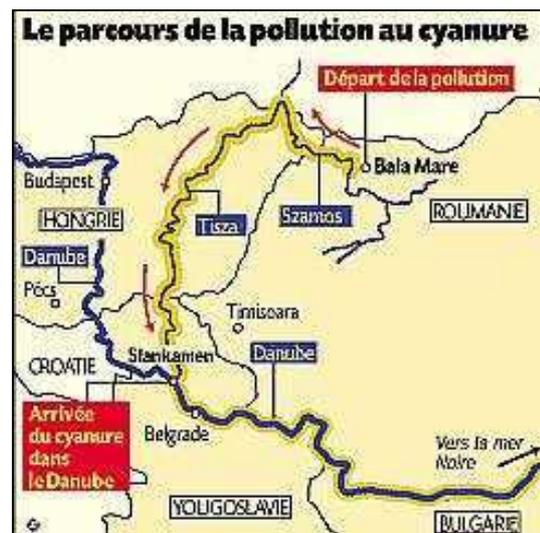
➤ On **February 4**, the cyanide tailing reached the TISZA, one of Hungary's main watercourses crossing into Serbia. Upon entering Serbia on **February 11**, the cyanide content of TISZA's polluted water was still measured at 2 mg/l.
