Explosion of a fireworks warehouse

May 13, 2000

Enschede

The Netherlands

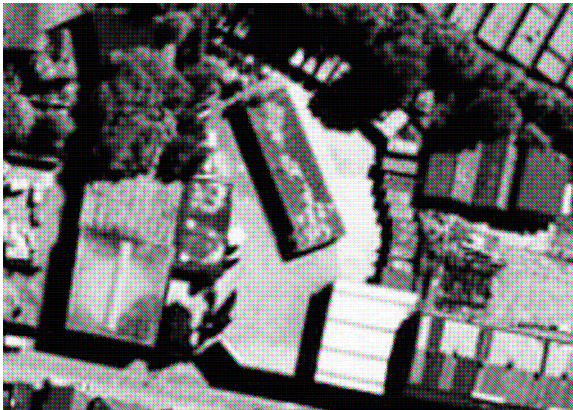
Aerial photograph of the site. On the day of the accident, two containers 20 feet longer were found onsite (Topographical Unit [2])

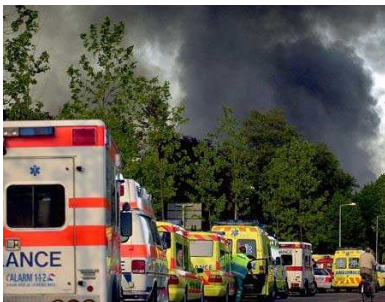
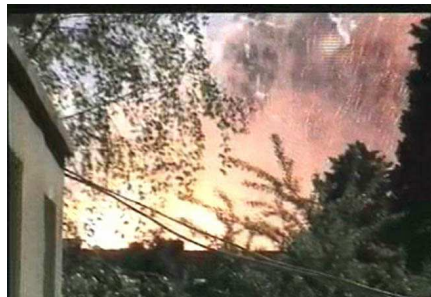
The company, most buildings in the accident zone and a number of residential structures in the vicinity were either destroyed or severely damaged.

As the fire was spreading, many "curious onlookers" were able to approach the scene, since the safety perimeter set up by police and emergency services ran too close to the explosive zone (see video accounts in [9-10]). The explosions created panic and left many of the local witnesses injured.

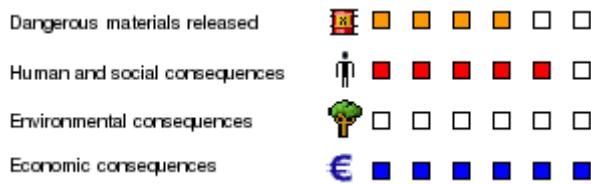
By applying the rating rules of the 18 parameters on the scale officially adopted in February 1994 by the Committee of Competent Authorities of the Member States, which oversees application of the 'SEVESO' directive, this accident can be characterised by the following 4 indices.

Two parameters are involved in determining the rating level of the "hazardous materials released" index: Q1 and Q2. In adopting the Dutch hypothesis of a net mass of fireworks equal to 30% of the gross mass, the quantities of fireworks having contributed to an explosive reaction (according to the table on page 3) are respectively 5 tonnes of class 1.4 and 48 tonnes of class 1.1, 1.2 or 1.3.

The overall "hazardous materials released" rating is thus equal to 4.

As a result, the overall "Human and social consequences" index rating is 5.

Parameters €15 and €16 of the "economic consequences" index are rated 6: The amount of property damage was estimated at €500 million (€15 and €16: ≥ €200 M).
