Pollution following an acid leak

May 26, 2000

Le Thillot – [Vosges]

Aquatic pollution
Tannery
Fixed storage tank
Sulfuric acid
Maintenance
Layout
Catchpit
Periodic inspection
Dead fish

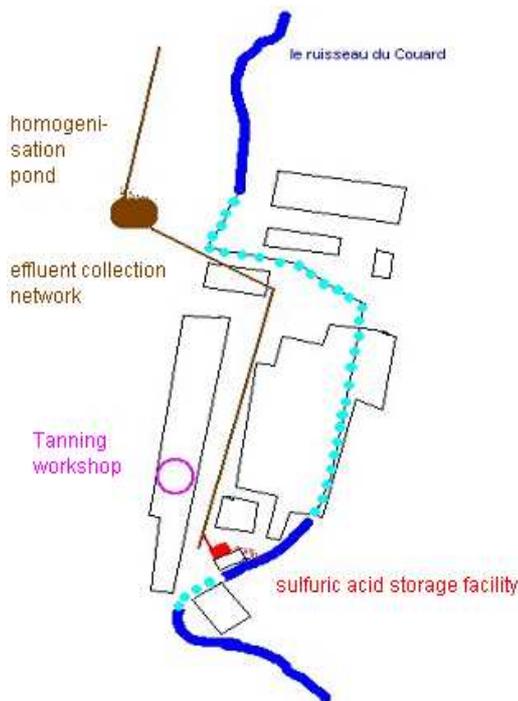
Diagram: DRIRE Lorraine

The existence of two contamination routes used by sulfuric acid should be noted:

- ✓ 6,000 litres directly in the site's settling pond menacing the treatment station
- ✓ 500 litres polluting the Couard stream (over 400 m), then the Moselle River (sur 500 m) and a supply channel. Extensive fish mortality was noted in these streams and in a fish farming operation.
