Butadiene leak in a chemical plant.

December, the 4th, 2000

Bassens – [Gironde]

France

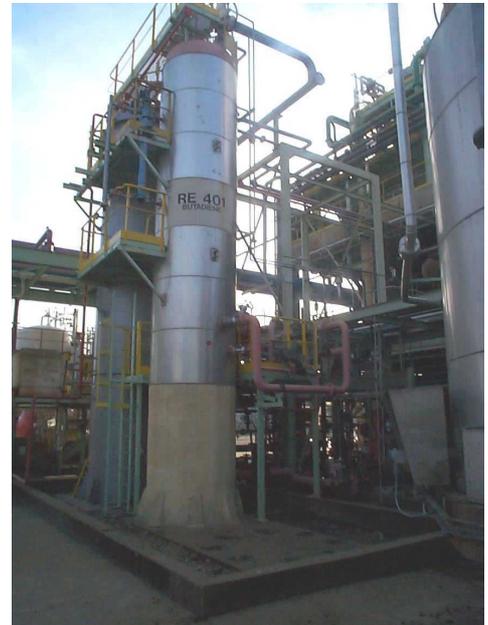
Spontaneous auto-polymerisation caused a brittle fracture of the valve in question. The valve served as a by-pass for a remote-controlled valve on the pressure control circuit in the butadiene tank. The forming of this polymer, known as "pop", in the valve cover was due to :

The increase in volume during polymerisation caused the internal pressure to rise sharply, thus causing the brittle fracture of the cast iron valve, the cover of which was torn off.

- ✓ The [quarter-turn] valve in question has been replaced by a steel ball valve, pending a detailed study of the problem with the by-pass. Two other cast iron valves have been replaced.
