# Explosion of dust in a silo

14<sup>th</sup> May 2001

Albert – [Picardy]

France

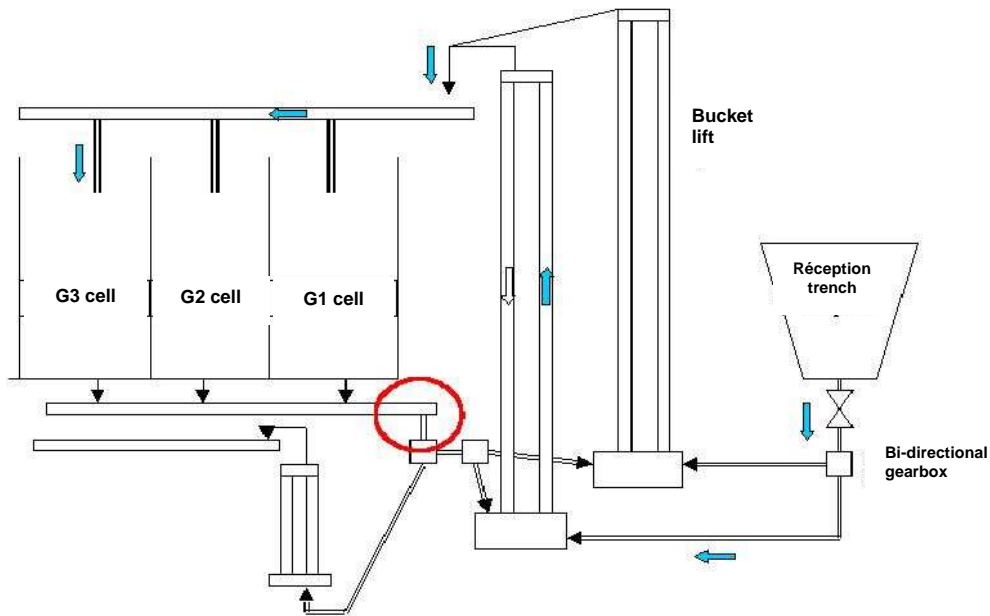
The damaged horizontal brick silo includes a reception/shipping area, a handling tower, the storage, the roofing and two underground overflow galleries.

The storage space is composed of two lines of 6 and 9 cells, completely open and separated by a corridor of roughly 2 m width and extending up to the total height. The cells are built with composite materials with reinforced concrete framing filled with hollow bricks. They are located in a metal structured building with walls and roofing in metal sheeting and plates of fibro-cement.
