## Explosion of a railroad tank car containing toxic gas

July 14; 2001

Riverview - [Michigan]

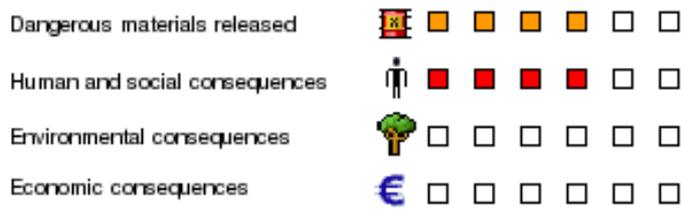
The 67 or 74 tons of methyl mercaptan released represent 33 to 37% of the corresponding Seveso threshold (200 t – highly flammable liquefied gas), which equals level 4 of the "dangerous materials released" index according to parameter Q1 (Q1 between 10 and 100%).

As the effects of the explosion had not been characterised and windows were broken at distances less than 300 m, parameter Q2 was given a rating of 1.
