Toxic leak in a dairy

August 29, 2001

Saint-Saviol – [Vienne]

Toxic release
Food industry
Refrigeration
Ammonia
Organisation
Training
Work
Circuit identification

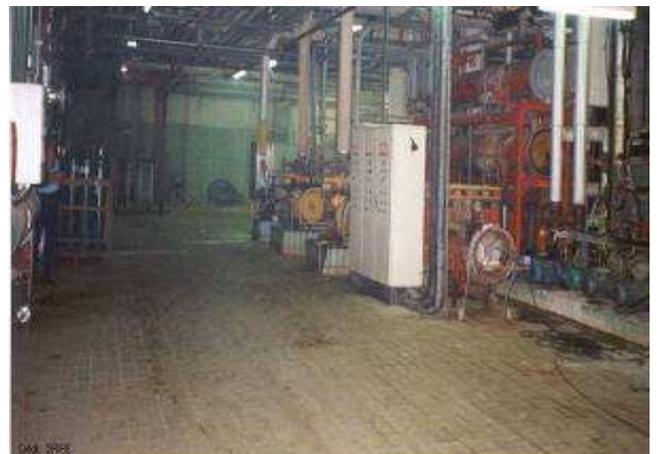
The installation consisted of 3 independent NH₃ circuits of 1 ton each, connected to a large ice tank, into which water flows to cool down the pipes containing NH₃ at – 10 °C, for plant requirements.

Each circuit includes a compressor, a multipipe condenser, a system of buffer cylinders and an ice tank used as an evaporator (cooling array).

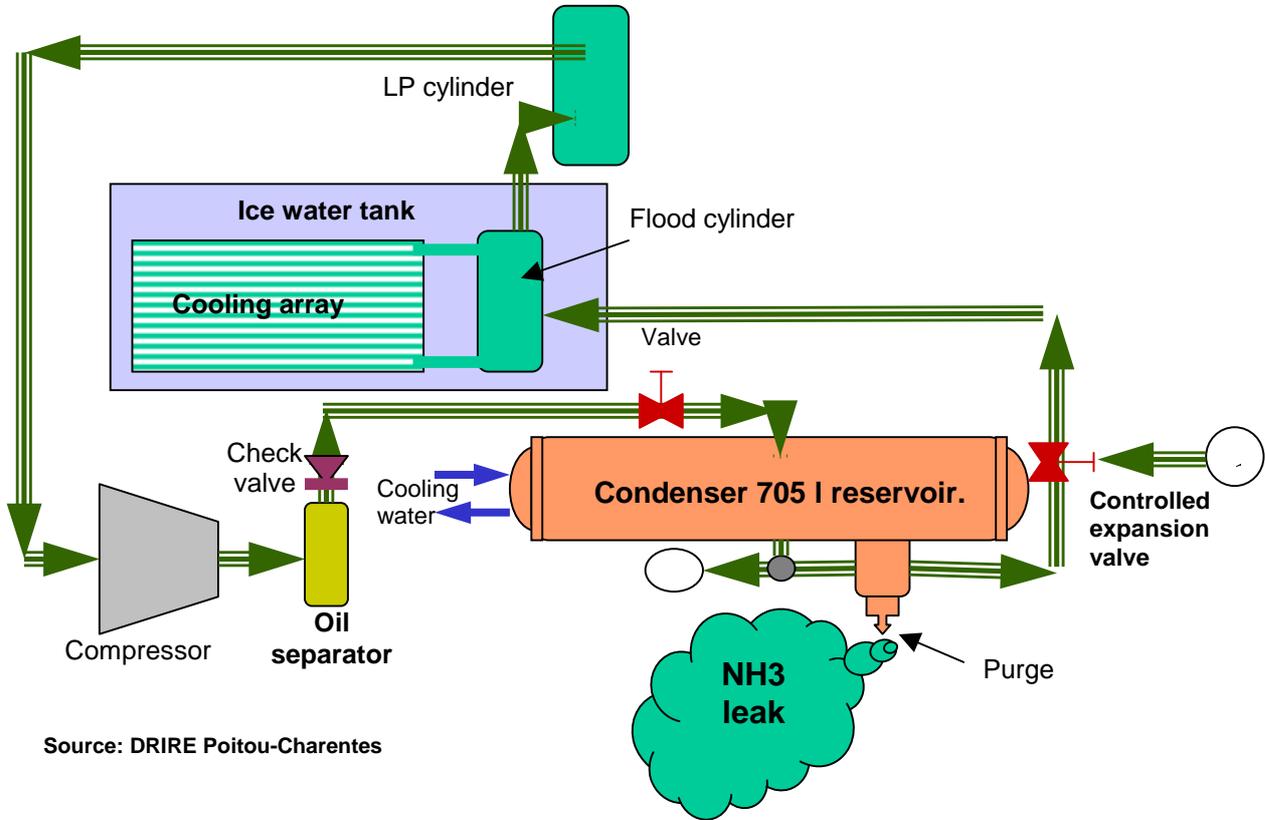
NH₃ (a toxic and flammable gas) is used in a closed circuit (Carnot cycle) from a hot reservoir (the condenser), in which it changes from a gas to liquid at ambient temperature (20 °C, 8.5 bar) toward a cold reservoir (the ice tank) where it changes back into a gas (- 10 °C, 3 bar), via the buffer cylinders downstream from the condenser and the compressor upstream.

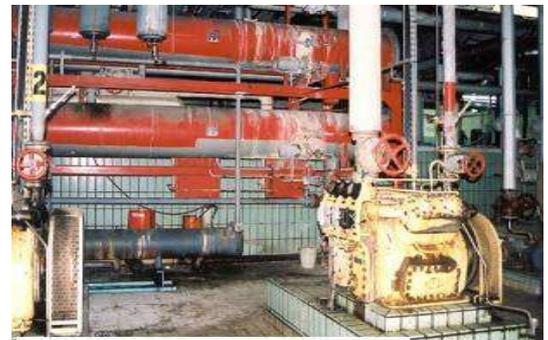
Heat is exchanged in a multipipe condenser for each circuit where the NH₃ condenses in contact with water coils to which it releases its latent heat of vaporisation. In this installation, the condenser also acts as a NH₃ tank.

A level measurement, with a built-in floater, controls the opening and closing of the upstream expansion valve which allows the NH₃ to be transferred from the condenser to the buffer cylinders and the evaporator, depending on the contents of the condenser.

A welding contractor from an external company had to perform operations on the cooling water circuit on one of the 3 condensers. The bolted retaining flange of the end dome on the condenser's shell was eroded. Water had been leaking for 2 days and management had decided to repair the oxidised part by a local welding operation.

Upon his arrival the next day, the welder found the part to be repaired to be still humid and requested a plant mechanic to finish draining the water circuit. The poorly informed mechanic thought that the purge button under the condenser should be used to perform the operation. He loosened it and allowed the welder to perform the additional drainage operation. The purge actually drained the NH₃ from the condenser.

Once repaired, the damaged circuit was also placed back into service roughly two weeks later.
