A series of explosions on alcohol tanks at a distillery

3 September, 2001

Lillers (Nord-Pas-de-Calais)

Explosion
Sugar refinery /
Distillery
Storage tanks
Alcohol / Ethanol
Potassium
permanganate
Explosive
atmosphere
Internal
contingency plan

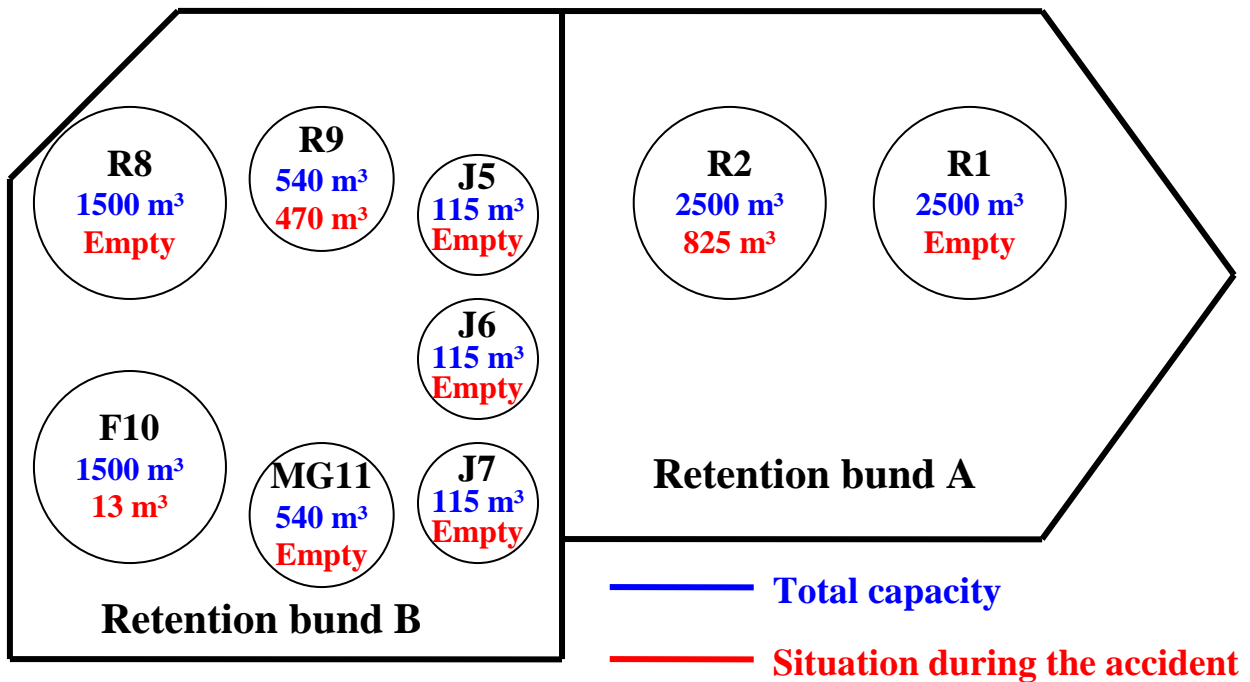
Scheme : DRIRE Nord - Pas - de - Calais

Operating losses are evaluated at 2.13 million Euros and property damage at 2 million Euros: 1,500 m³ tank (F10) (structure collapsed) and 540 m³ tank (MG11) (roof blown off) destroyed, and the roofs of three 115 m³ tanks ripped open.

According to the subsequent expert evaluation, it appears that the explosion of tank F10 was due to the ignition of an explosive atmosphere (ATEX) made up of alcohol vapours and air, present in the void of tank F10. The ignition was caused by a strongly exothermic reaction between a surplus of oxidizing agent, the potassium permanganate (KMnO₄), and the aqueous ethanol solution at 96%. Owing to the domino effect, the consequences of the accident were worsened by the damage caused to the other tanks.

- Installation of a fog screen between the bunds;
- Installation of a fire detection coupled with the activation of the spray rings and of the spraying system with alarm report in the guardhouse;
- Installation of alcohol and fuel detectors alarm report of the alarm thresholds in the control room ;
- Reconstruction of the tanks with ventable roofs;
- The solid permanganate was replaced by diluted liquid permanganate liquid after the process was validated.
- Installation of foam pourer on each bund;
- Inertage of the tanks with nitrogen.
