## Explosion in a chemical reactor

January 29, 2002

Calais – [Pas-de-Calais]

Fine chemistry  
Catalyst  
Methanol  
Washdown  
Nitrogen inerting  
Organisation

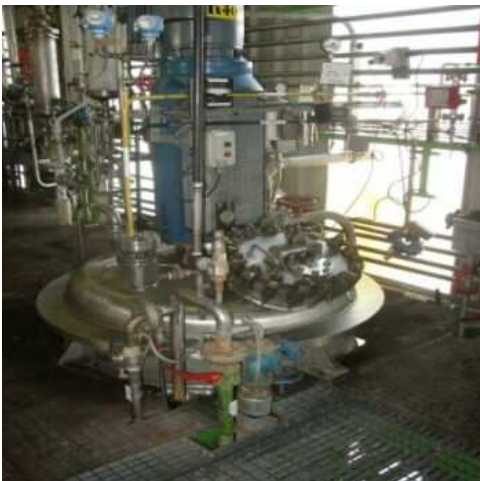
**On January 27th at 1 pm**, a hydrogenation operation was completed in reactor R404 (this manufacturing formula is relatively infrequent, even rare, as the last series was performed more than 6 years ago). Six washdown operations with water were conducted to eliminate traces of reaction catalyst (Palladium) as well as two hot methanol stripping operations (30°C) to eliminate traces of organic compounds still contaminating the reactor.

**On January 28 at 2.40 pm**, reactor R404 was allowed to drain. **At 9 pm**, it was heated empty to 80°C for a period of 8 hours.

**On January 29 at 5 am**, the operator, before leaving his work station, shut down the heating, re-established the pressure with nitrogen and opened the air vent to allow the reactor to cool down naturally.

On January 29 at 10 am, the foreman cooled reactor R404 for its subsequent examination. An hour later, the foreman noted that the inside of the reactor was "a bit tarnished and a bit humid with a residual trace on the bottom". At 5 pm, following this assessment, the shop supervisor requested that the reactor be washed again. Analyses of the methanol wash solution confirmed that the previous washdowns were inefficient: synthetic and intermediate product was detected.

An operator was found lying next to reactor R404, and his face seriously burned.

The reactor and the related installations showed no signs of visible damage. The reactor's gasket had been ejected a few metres away. The reactor was immediately closed and injected with nitrogen.

The modifications proposed by the operator, and in particular the change of the procedure for cleaning the R404, as well as the new gasket cleaning and inerting procedures, must ensure that operations take place in improved safety conditions.
