Emission of dangerous substances in a surface treatment facility

March 20th, 2002

Issoire [Puy-de-Dôme]

Gaseous release
Metallurgy
Pickling
Fluoronitric acid
Aluminium
Exothermic reaction
Equipment breakdown
Periodic control
Evacuation

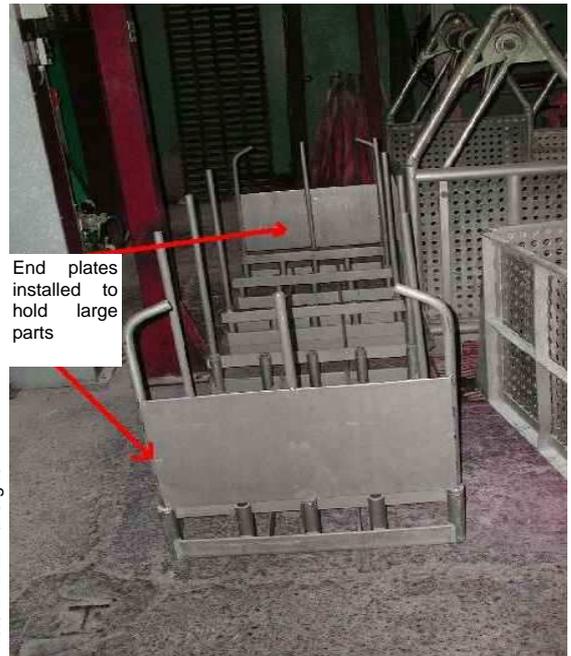
- the modifications made in the design of the units and in their operation since the initial authorisation,
- the physical and chemical characteristics of the products used or stored, while integrating the last known studies, particularly for hydrofluoric acid,
- the analysis of significant accidents involving this type of installation,
- the type and consequences of a possible accident on the units, with the definition of precise reference scenarios,
- specific measures to reduce the probability and the effects of accidents.

Following this study, in addition to the modification of the baskets, the operator agreed to undertake the following actions:

- periodic verification of the hoists (internally and by an approved organisation),
- installation of a visual and audible alarm when the normal operating temperature is exceeded,
- installation of a system to ensure gravitational bath drainage of nitric and fluoronitric acids into an underground tank, thereby preventing a runaway,
- use of a trolley with telescopic forks and a rotating hook to mitigate possible failure of the basket handling hoists,

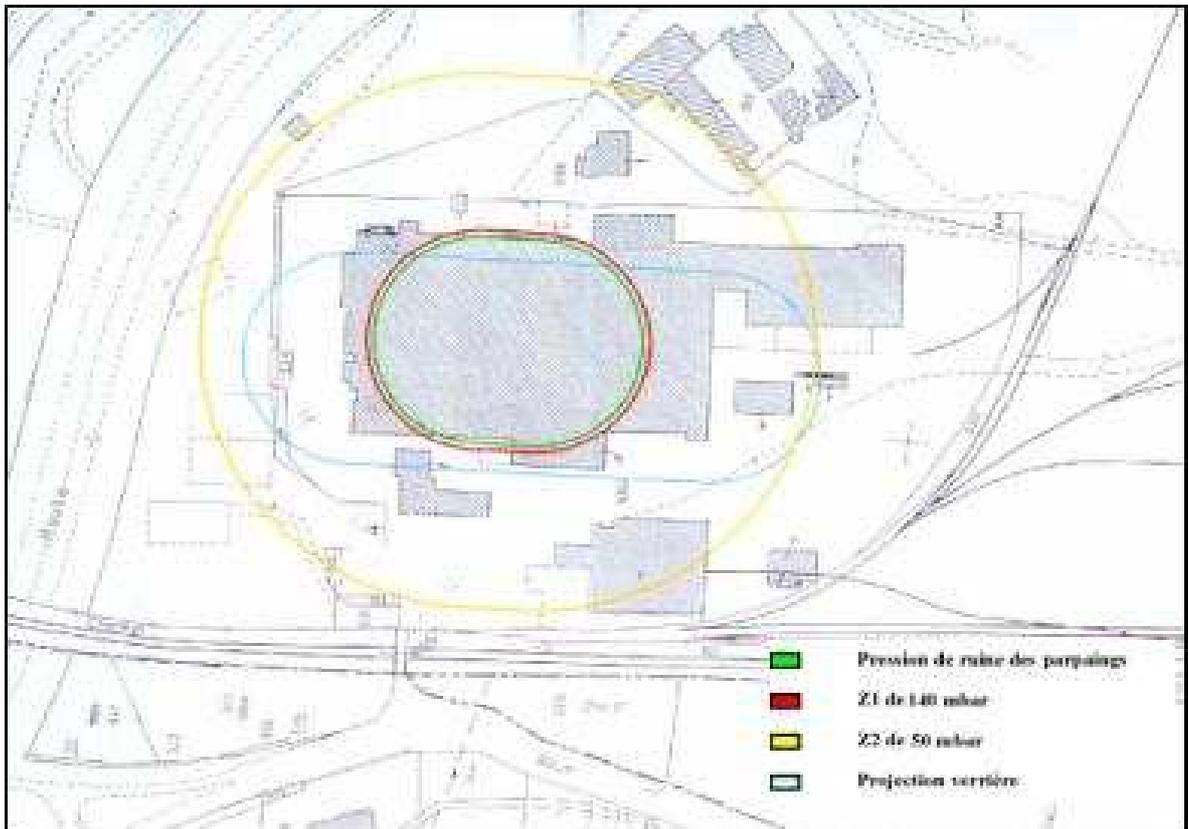
Beyond the chemical hazard potential, the study also estimated the risks presented by the explosion of the high pressure compressed air tanks (5 m³ at 250 bar). The modelling particularly shows that nearly all of the manufacturing shops are within the overpressure zone (55 m) of 140 mbar (lethal effects) and that the 50 mbar zone extends up to 120 m from the source.
