Blazing leak in a gasoline hydrotreatment unit of a refinery

November 17, 2002

Grandpuits Bailly Carrois [Seine et Marne] - France

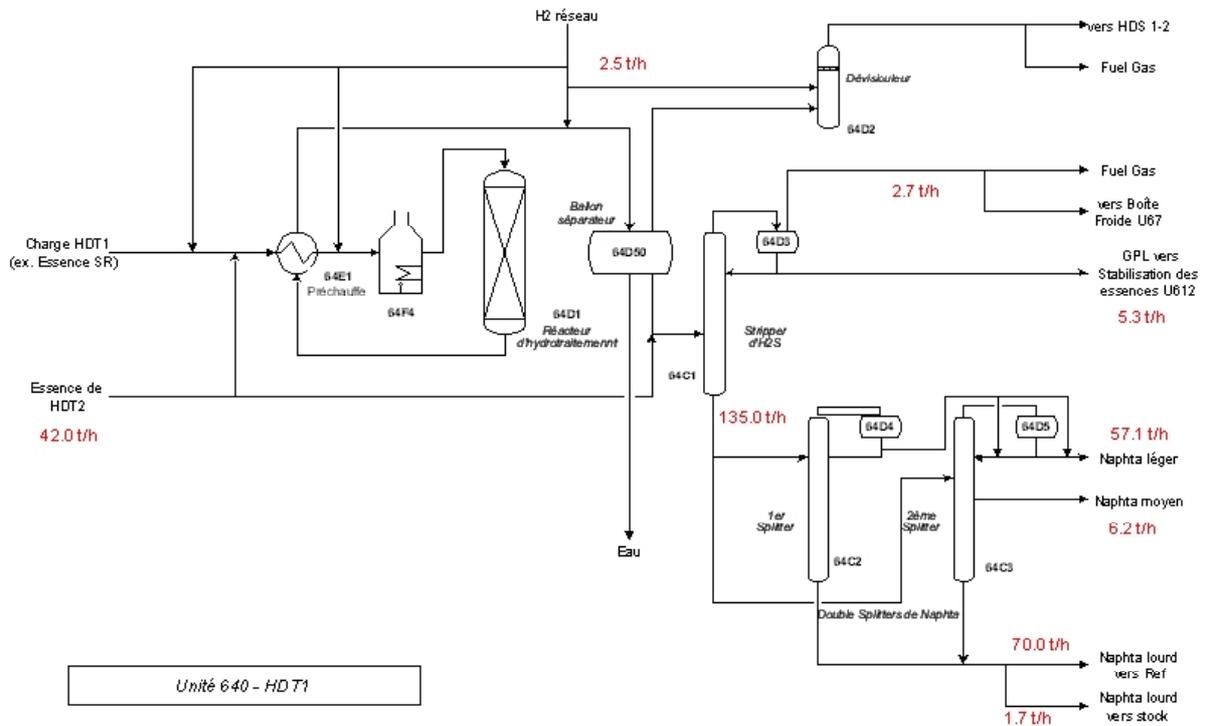
UNITE HDT1

The leak occurred on the gasket plane of the reboiler, on the hot fluid side, and immediately burst into flames producing a nearly vertical flame cone roughly ten meters in length.

The reboiler is designed to supply the energy required for column operation, which includes the pre-treatment stripper, on which the hydrotreatment unit depends. This is a preparation phase for the reformer's load. The reboiling energy is furnished by the reformer's effluent. The complete diagram of the unit, including the loop shown opposite, is represented on the following page.
