Cyclohexane leak in a chemical plant

December 16, 2002

Chalampé (68 – Haut Rhin)

Chemical plant

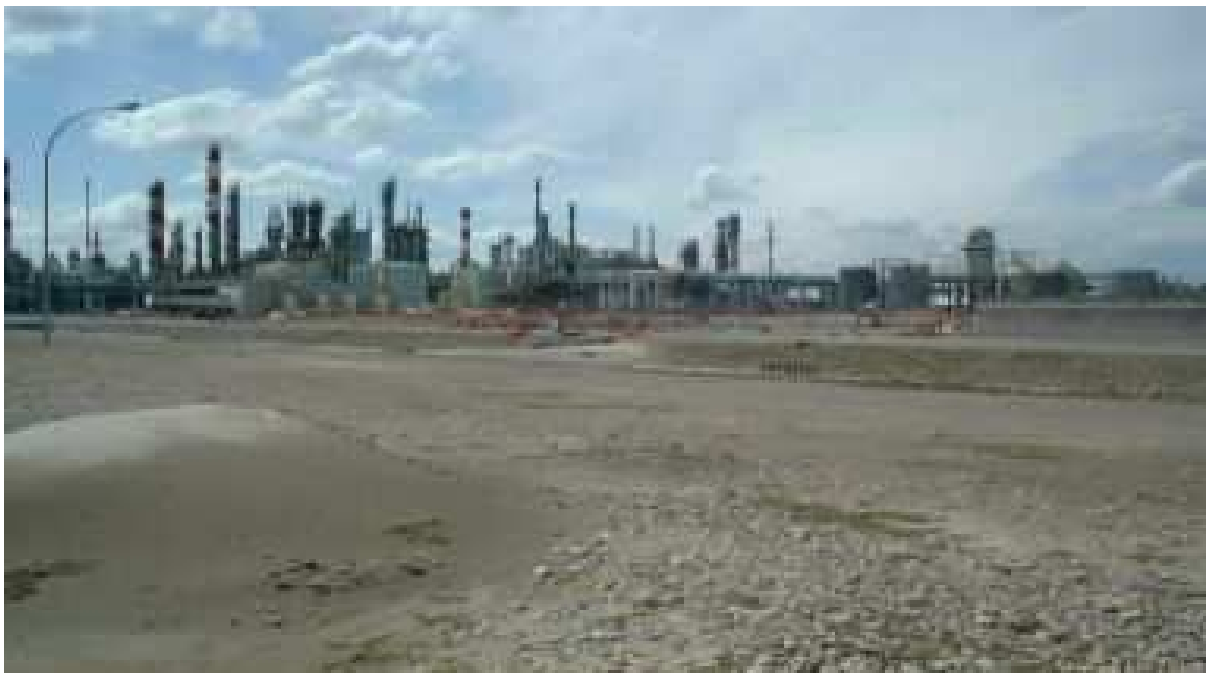
In **July 2004**, 590 tons of cyclohexane were extracted from underground (more than 90% of which was in supernatant form), using the 3 recovery systems in place: skimming of the supernatant, venting, sparging. However, stabilisation in the quantities recovered was noted at the start of the year (a dozen tons per month). As such, a long term remedial plan is required to treat the pollution.

Studies are underway aimed at bio-remediation of the pollution using bacterial strains, specifically intended to denature the cyclohexane, detected along the periphery of the polluted zone.
