Explosion in a cartridges-filling workshop

July, the 30th, 2002

Burbach-Wurgendorf

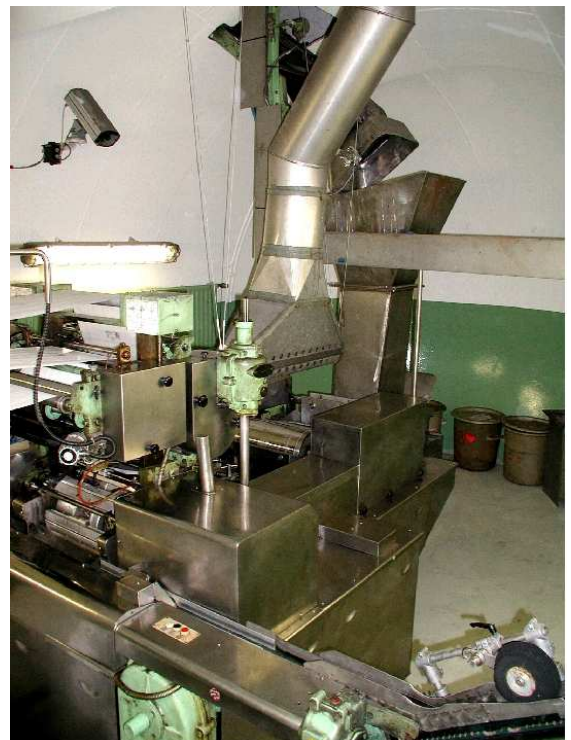
✓ Producing cartridges in separate buildings:

- × There is no more presence of any persons if the machine producing cartridges works also during starting and stopping. The entrance of persons is only for cleaning and repairing in the case the plant is out of action. This is guaranteed by key-operated switch and locked entrance regions.
- × Critical combinations of materials like metal on metal will be prevented in the future to avoid ignition sparks.
