## Chlorine leak in a liquefaction workshop of a chemical plant

January 13, 2004

Vieux-Thann – [Haut Rhin]  
France

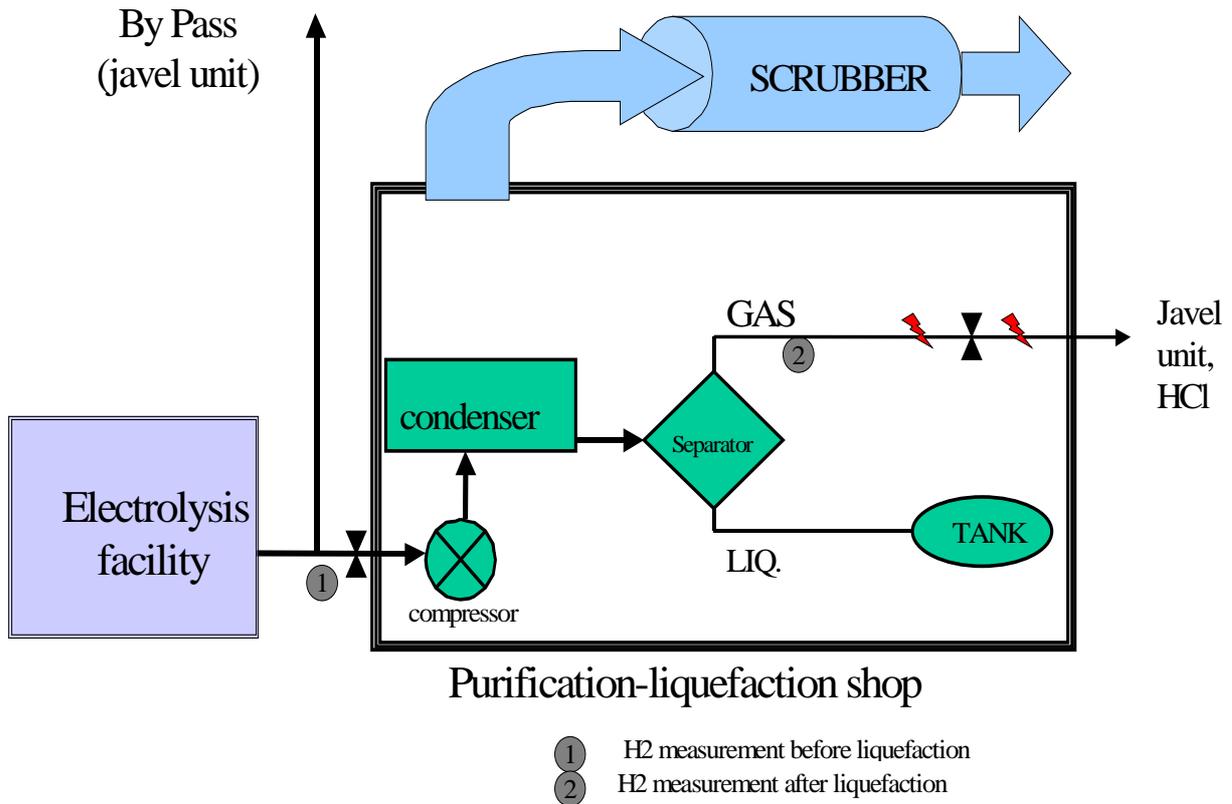
The chlorine coming from the electrolysis facility is compressed and condensed, and then the gas and liquid phases are separated in a floatation pot-type separator. The liquid part is then directed to the storage facilities or to the loading installation. The non-condensed part (referred to as residual gases), containing gaseous chlorine and non-condensable gases (notably H<sub>2</sub> and air) is distributed on site. As the liquefaction rate increases, the concentration of non-condensable gases in the residual gases also increases (the enrichment factor is  $[1/(1-\tau)]$ ). As such, if 50% of the chlorine is liquefied, the concentration of the non-condensable gases in the residual gases doubles, but is multiplied by 10 if the liquefaction rate is 90%.

The presence of hydrogen and inert gases, inherent to the chlorine manufacturing process, is particularly important during the installation restart phases, notably after long shutdown periods.

The automatic hydrogen analyser is inoperative during the installation's start-up phases due to the excessive quantity of inert gases present. For this reason, during installation start-up operations, the operators perform manual concentration measurements (a measurement every ten minutes, according to the procedures).
