Explosion of a fireworks fabrication and storage facility

June 01, 2004

Villeneuve sur Lot (Lot et Garonne)
France

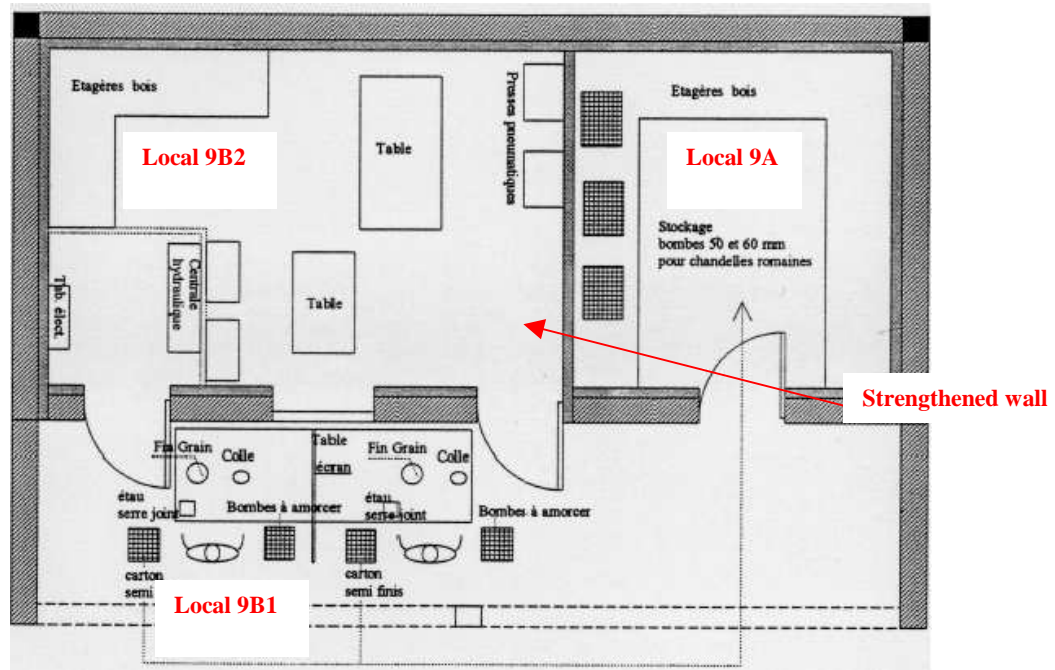
The workshop (building 9), involved in the accident, was dedicated to the manufacture of candles. It contained two workstations and a storage facility. Three consequential activities are performed:

- ✓ the shell assembly area, under the building's awning (facility 9B1). The operation consists in manually filling the lower part of the plastic shell with a bursting and star charge, and then to bond it with the upper part and arm the shell formed;
- ✓ intermediate storage of these products in storeroom 9A. The shells are stored in plastic boxes stacked on 5 levels on the wall separating this area and facility 9B2;
- ✓ the shells are loaded into the candles in facility 9B2. This operation consists in using a low-power hydraulic press to insert a series of armed shells and cups filled with powders into a cardboard tube with a closed base. The composition of these powders ensures the ejection of the shell from the tube.

The authorisation to operate this building prohibits the simultaneous shell assembly and candle loading operations. The shell storage facility was authorised to contain a maximum of 300 kg of active ingredients, characterised as non-detonating products (closed and armed shells). The maximum capacity of the two assembly and loading workshops was 5 and 2 kg of detonating products, respectively, owing to the handling of the powder.
