Fire in an electrical service room in a chemical plant and release of toxic gas

October 25, 2004

Lannemezan - [Hautes-Pyrénées]
France

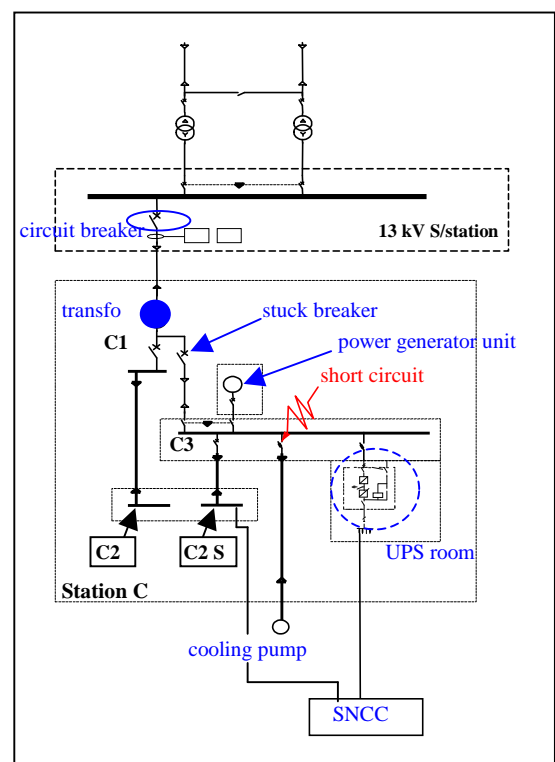
2.40 pm: the burst disk opens (0.5 bar) on the hydrazine unit's vent treatment tower. Water curtains are installed around the tower and a mobile cannon is set up to combat the ammonia release exiting the tower's vent.

The electrical column where the short circuit took place was destroyed by the fire and the entire electrical switchboard C3 was badly damaged.
