# Explosion in a fireworks storage facility

3 November 2004

Kolding

Denmark

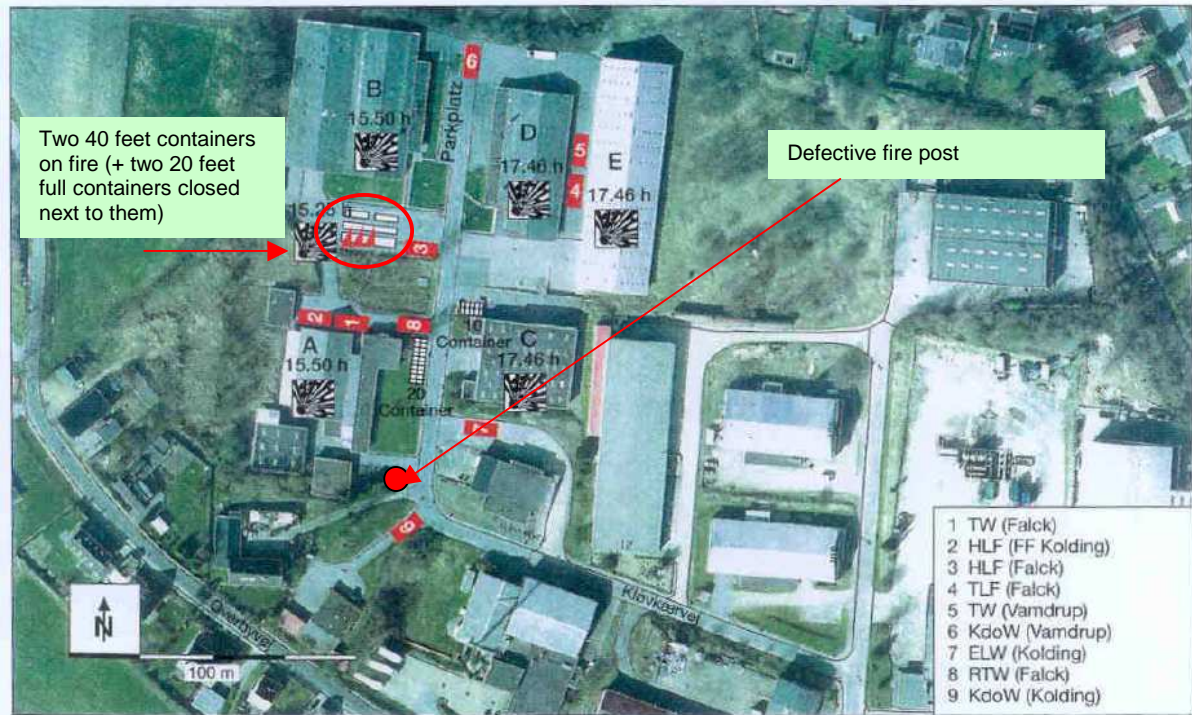
Fire in the 2 containers at 3 p.m. [2]

The emergency team faced difficulties in the rescue operations. The fire-fighters were unable to target the water nozzles directly at the entrance of the two containers due to the thick cloud of smoke and the explosion of fireworks. Moreover, the nearest fire post was out of order thus complicating water supply. The police decided to evacuate residents within a perimeter of 500 m.

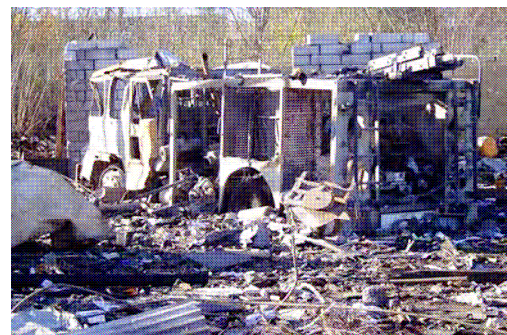
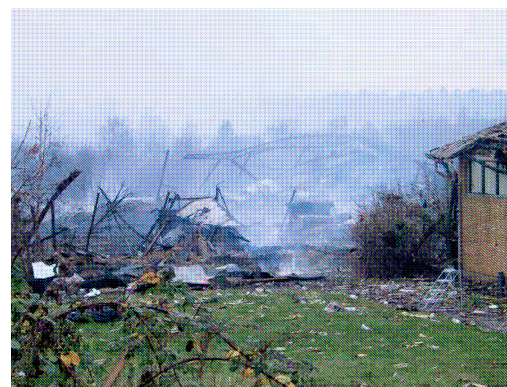
The company, most of the buildings in the industrial zone and a part of the residential buildings in the neighbourhood were destroyed or severely damaged: 450 houses were damaged and some were made unfit for living. Debris of the buildings were found over 1,000 meters away from the disaster.

The containers between the buildings burnt for several hours without exploding. Some of them were deformed by the heat and the possible rise in internal pressure.

Aerial view of the site after the accident (cf. photo on first page)
