Explosion of a fireworks storage

14 February 1991

Culemborg

The Netherlands

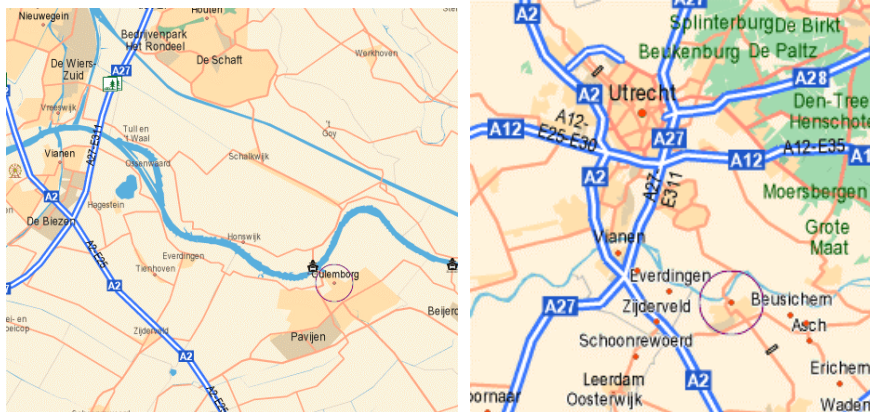
The fireworks storage depot was located 5 km south west of the town of Culemborg at 15 km to the south of Utrecht in the centre of the country.

The facility comprising two buildings was at 50 metres from a 5.8m high dike. The Farmhouses and homes were mainly built along the other side of the dike. There were two farmhouses on the same side of the dike at 200 m from the facilities. The dike was the only elevated point of this rather flat landscape.
