Polluted effluents released into the Cher River

14 September, 2005

**Saint Victor – [Allier]
France**

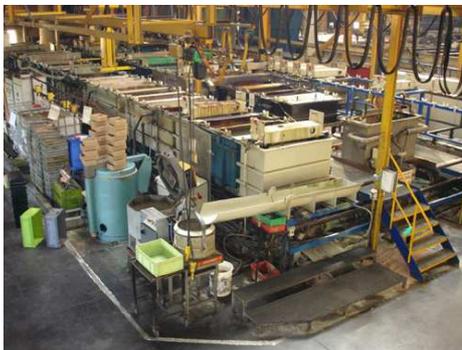
Photo DRIRE Auvergne

The plant, located in the town of Saint Victor in the French region of Allier, was built in 1994 and designed to perform surface treatment operations on metal parts, particularly various grades of zinc plating on automobile parts. In 2005, the plant employed 34 persons and posted sales of 1.6 M euros.

The plant consists of a 3,530-m² covered building housing 2 surface treatment lines, a rack system and a bulk system. Both systems represent a total bath volume of 196 m³.
