# Explosion during a cupola drop inside a foundry

May 15, 2006

Vivier-Au-Court [Ardennes]

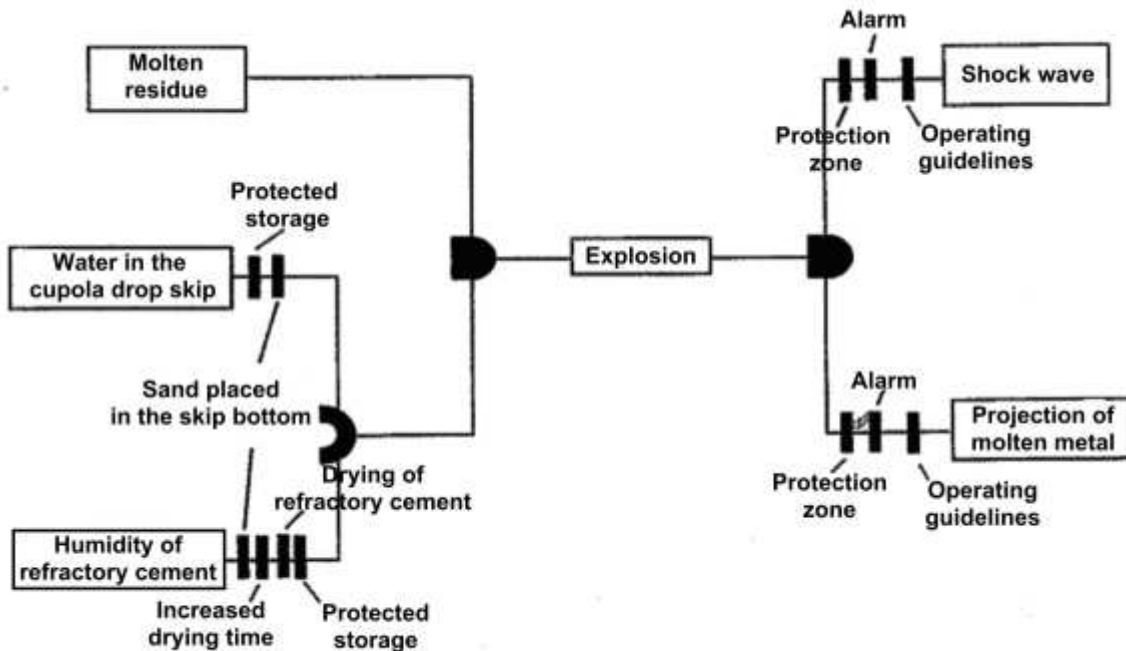
Several technical and organisational measures were adopted in order to reduce the probability that such an accident repeats as well as to remedy the effects of an eventual accident. The following identification of technical safety barriers for prevention and protection was performed as part of the Safety Report update:

→ the technical measures were primarily focused on removing humidity in the metal skip, for the purpose of eliminating the risk of explosion due to contact between residue after melting (cast iron residue) and water, i.e.:

- ✓ acquisition of three skips so as to better manage equipment utilisation and ensure sufficient drying time for the refractory cement (36 hrs). Skip labelling was also introduced;
- ✓ storage of this containment capacity at a site protected from water;
- ✓ drying of the skip intended for daily cupola drop using a gas burner;
- ✓ placement of a bed of black foundry sand at the bottom of the skip to both eliminate all eventual traces of residual humidity and provide additional protection at the skip bottom.

→ organisational measures to enable limiting the number of individuals working in the hazardous (so-called "protection") zone where the cupola drop takes place:
