Leak on a pipe conveying MTBE

October 2004

Stein Port - The Netherlands

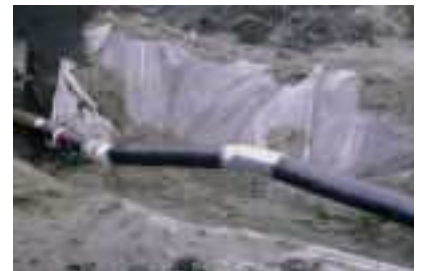
A crack on a pipe weld resulted in the MTBE leak. This defect resulted from multiple failures during the construction of the pipeline.

The welding of this junction part, poorly performed and left unchecked, caused the pipe to crack. The crack, the appearance of which remains difficult to establish, most certainly widened over time, notably due to ground motion.

Crack on the weld
Source: VROM-Inspectie (The Netherlands)

Following the detection of the pollution in October 2004, the pipeline was repaired and several methods were used to treat the site's polluted zone:
