Fires and BLEVE of LPG tanker lorries

7 May 2007

Dagneux (Ain)

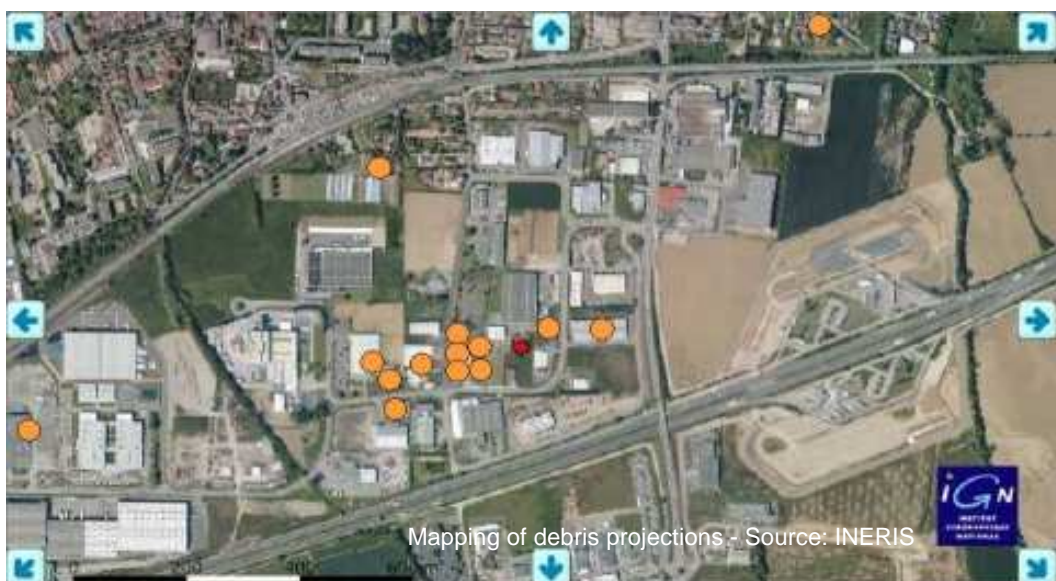
The alignment of these projections was, for the most part, perpendicular to the vehicle parking arrangement, except for 2 fragments, the larger of which (weighing 1 tonne) was found to the north-west 400 m from the point of explosion while the other (100 kg) crossed the roof of a dwelling 700 m north-east. Eleven of the 14 inventoried impacts, including the 15-m³ tank, were recorded west of the parking lot. Several industrial facilities were also damaged by these impacts.

The maximum height reached by these debris projectiles during their trajectory could not be discerned, though video recordings revealed that some may have soared to between 50 m and 100 m.
