Fuel oil spill in an estuary during a transfer operation

March 16, 2008

**Donges – [Loire Atlantique]
France**

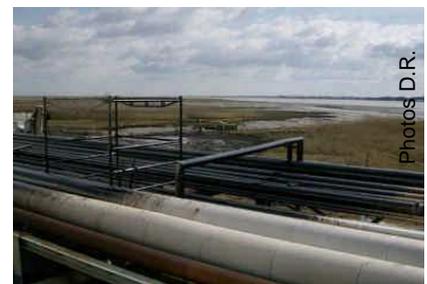
The leak occurred on a pipe approximately 4.5 km long connecting a cargo fuel oil storage tank to a ship loading station.

At the leak point, the rack supporting the defective pipe runs parallel to the gas storage zone at the periphery of the Loire River banks over a length of some 300 m.

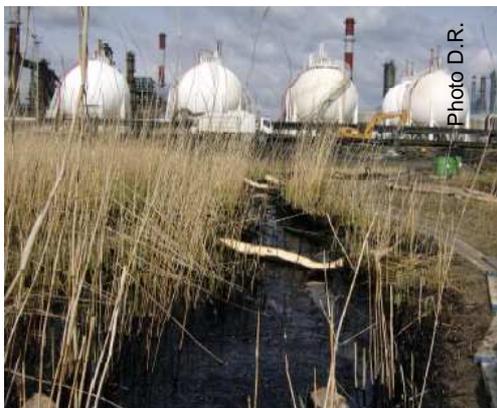
The assessment of extent of impact on the flora and fauna was promptly initiated by conducting from the outset an accurate inventory of the detrimental effects to birds. Biweekly observations recorded by the National Office for Hunting and Wildlife revealed that the number of bird deaths caused by this pollution spill was less than 10 throughout the entire Loire-Atlantique Department.

The proportion of soiled birds kept decreasing as pollution cleanup progressed, with the affected bird population gradually leaving the zone as time went by.
