## Disposal of wood treatment product

22<sup>nd</sup> April, 2008

Lannilis - Finistère

Toxic releases  
Wood treatment  
Water pollution  
Organization and  
human failure

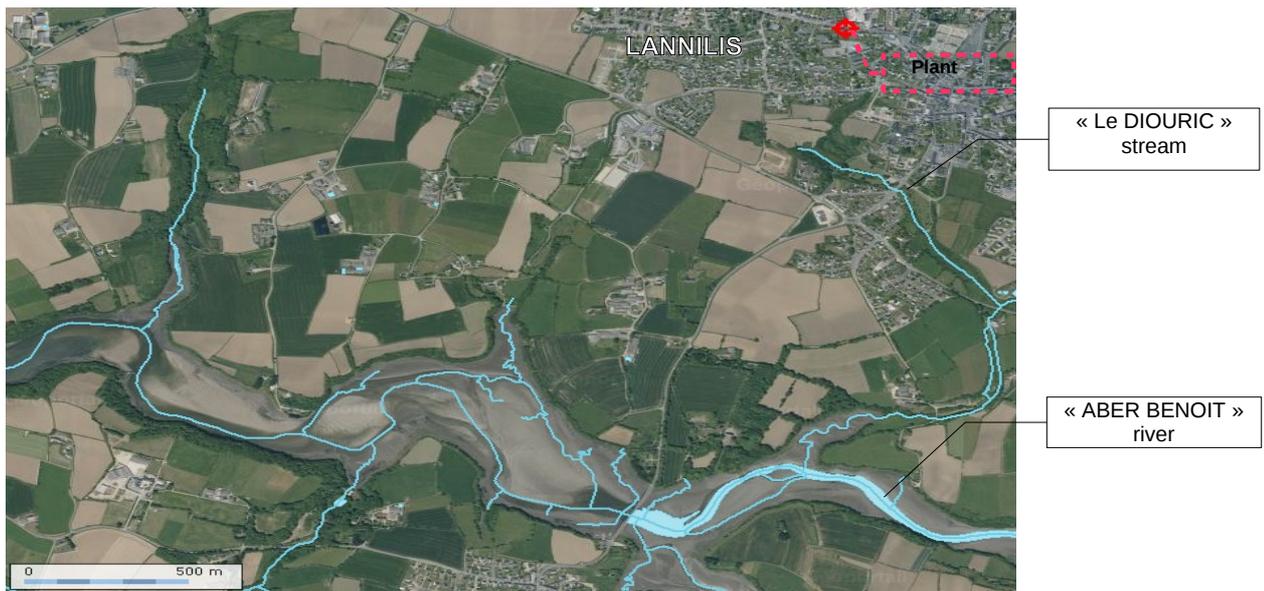
The quantity of wood preservative flowing into the site's stormwater drainage network was estimated at between 8 and 12 m<sup>3</sup>. Cleaning of Lannilis' municipal storm drains allowed recovering a small portion of this volume. In all, the quantity reaching "Le DIOURIC" watercourse was on the order of 6 to 10 m<sup>3</sup>, as the product dilution in water made this quantity impossible to recover.

Hydrographic profile - Source: Géoportail
