Explosion of a shell within a scrap metal recovery company

May 14, 2008

Vierzon [Cher]

Scrap metal storage
Munitions (shells)
Picric acid
Explosion
Organisation /
procedural aspects

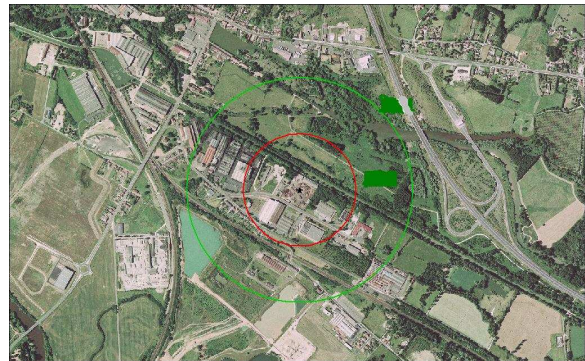
A sizeable stockpile containing 100 to 200 tonnes of blank shells, discarded shell casings, inert training shells and other non-explosive shells stemming from an array of companies specialised in armament was present on the site, in addition to other products, including shells of unknown origin. Some of these very dated products had been stored at the facility for many years.

Two blowtorch cutting stations, separated by roughly ten metres, were set up outdoors amidst four large heaps of shell casings. The accident occurred at the south-western part of the facility, just opposite the compartment where these items had been stored.
