High-risk derailment in a city centre

16th March, 1992

Aix-les-Bains (Savoy)

Transport of dangerous goods
by rail

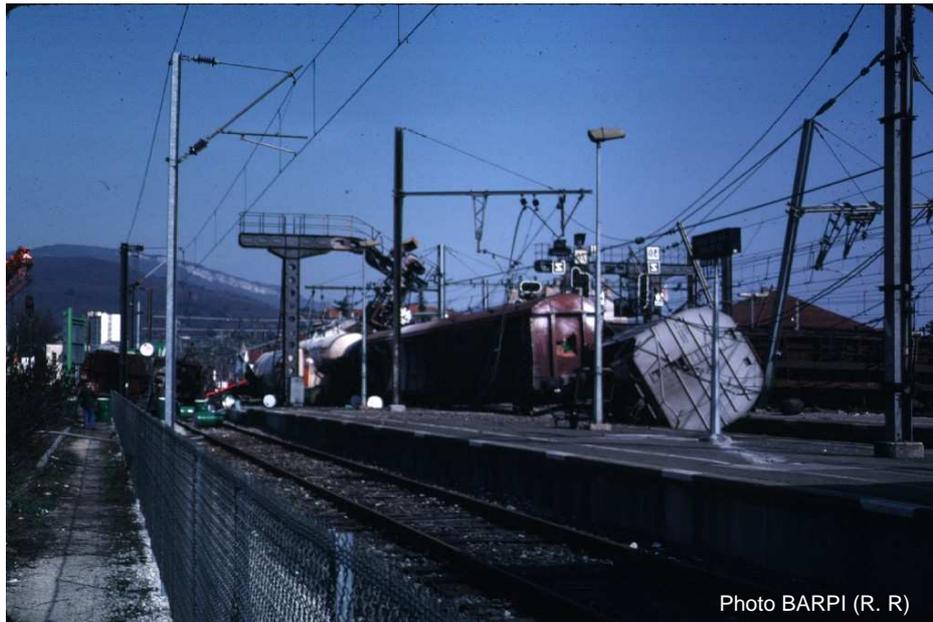
Photo BARPI (R. R)

Thanks to an overall favourable context, coupled with the resistance of these tanker cars and the rapid emergency response, this accident was not responsible for any significant environmental impact. Only the municipal treatment plant was slightly polluted by runoff water through the storm drains from the water curtain used to fight the blaze.

Attention should nonetheless be focused on the potential disaster of this accident, which was avoided thanks to the efficient tanker car design (specifically its shock resistance). Under the hypothesis of a major break in the ammonia tank, even the least pessimistic models would have forecast fatalities out to 1 or 2 km from the accident (for a 80-mm diameter break and a wind speed of between 1 and 4 m/s).

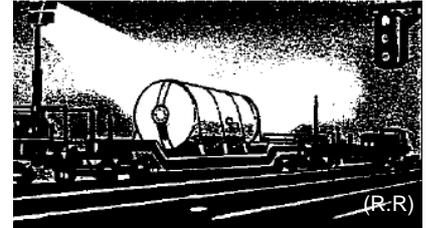
On 18th March around 3:30 pm, approx. 700 people were evacuated from the convention centre. The lifting operation began at 4:30 pm. Two hours later, the DMA tanker car was loaded onto a lowered railcar, framed by 2 flatbed cars carrying safety equipment. The entire assembly was hauled as a special convoy to the Culoz marshalling yard, in the Ain Department. Since the convoy exceeded clearance on the left side, it had to circulate on the opposite track (i.e. on the right) to allow passing through tunnels. In all, the trip lasted nearly 3 hours travelling at 8 km/h.
