Wall rupture of a cereal storage silo and "domino effect" on a propane tank

August 19, 2008

**Saint-Hilaire-sur-Puiseaux (Loiret)
France**

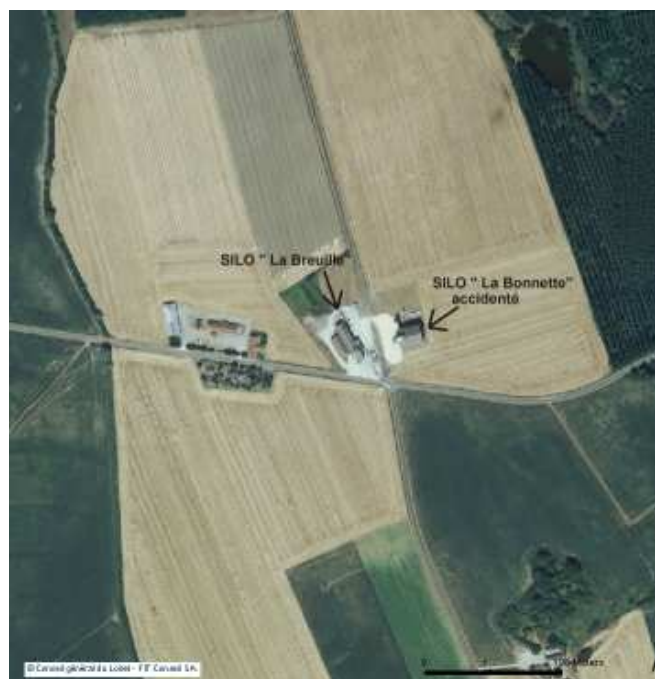
2,100 tonnes of wheat and 1,000 tonnes of corn spread over a distance of roughly 15 metres following the wall rupture on cells 3 and 5, each with a 3,000-m³ capacity, causing partial collapse of the propane tank installed in the vicinity.

This overflow of grains caused the tank to move laterally and in turn burst the LPG pipe (in gaseous phase) between the tank and the relief valve; the flow limiter positioned at the level of the tank was closed yet retained a minimum leak that was sealed off when fire-fighters closed the valve placed on the pipeline located upstream of the rupture.

The accident was related to the rupture of silo walls due to both the state of structural fatigue and a drop in cereal stock along with the partial tank collapse, thereby causing a gas leak. A flaw had been detected by the operator during silo construction in 1989, triggering the need for structural reinforcement works on the site in 1990.

- ✓ 1 – Site closure
- ✓ 2 – Inerting the LPG tank
- ✓ 3 – Onsite monitoring
- ✓ 4 – Verification of silo structural condition
- ✓ 5 – Drainage of all silo contents
- ✓ 6 – Issuance of a burning permit
- ✓ 7 – Service start-up only after expert review.
