# Flooding of a pharmaceutical plant

01/11/2008

Saint-Germain-Laprade (43)

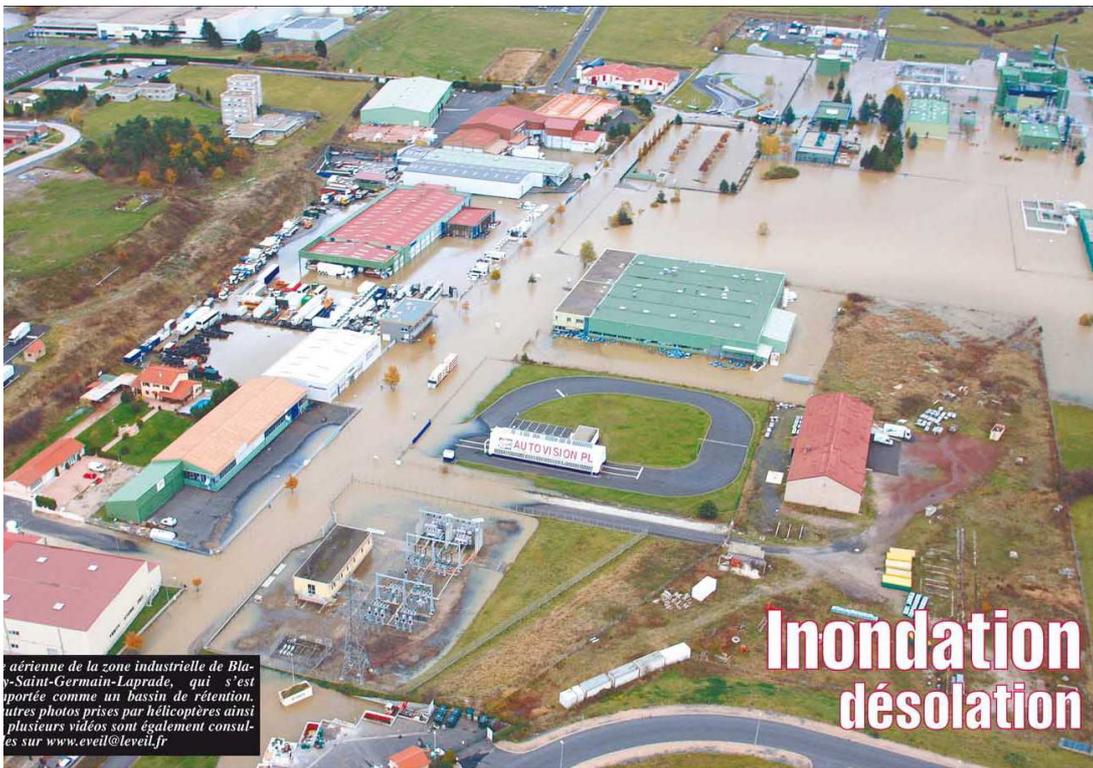
St Germain Laprade industrial zone (source: L'Eveil de la Haute Loire)

Following a spell of torrential rains (about 300 mm from 31 October to 2 November with a 3-hour extremely heavy downpour), insufficient draining of the water from the catchment area housing the industrial zone caused flooding. The water level in the entire site reached 20 cm to 1 metre.
