# Derailment of LPG tank-wagons followed by a UVCE explosion and an intense fire

29 June 2009

Viareggio

Freight transport  
Derailment  
LPG  
Maintenance  
Tanker-wagon  
Explosion (UVCE)

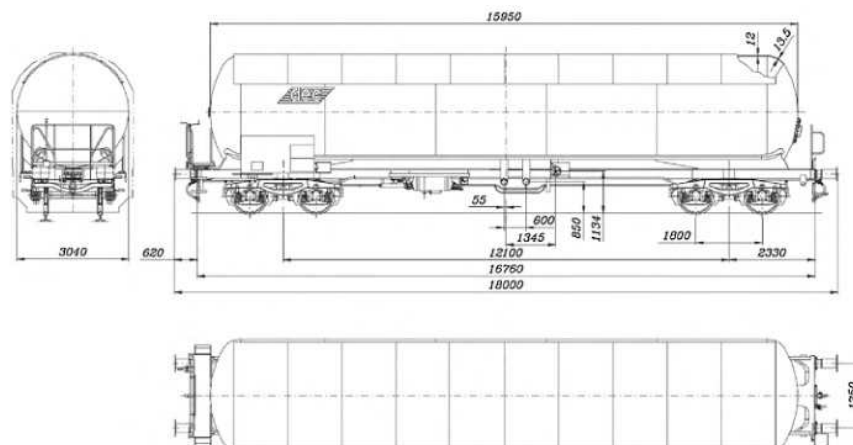
Fig. 1: Rail-tanker 462 R geometrical characteristics (mm)

The first rail tanker, which derailment created the LPG release, was a cylindrical tank model 462R (fig. 1), 15,95 m long and 3,04 m of diameter [5]. The derailment was probably caused by the rupture of one of the wheels axes.

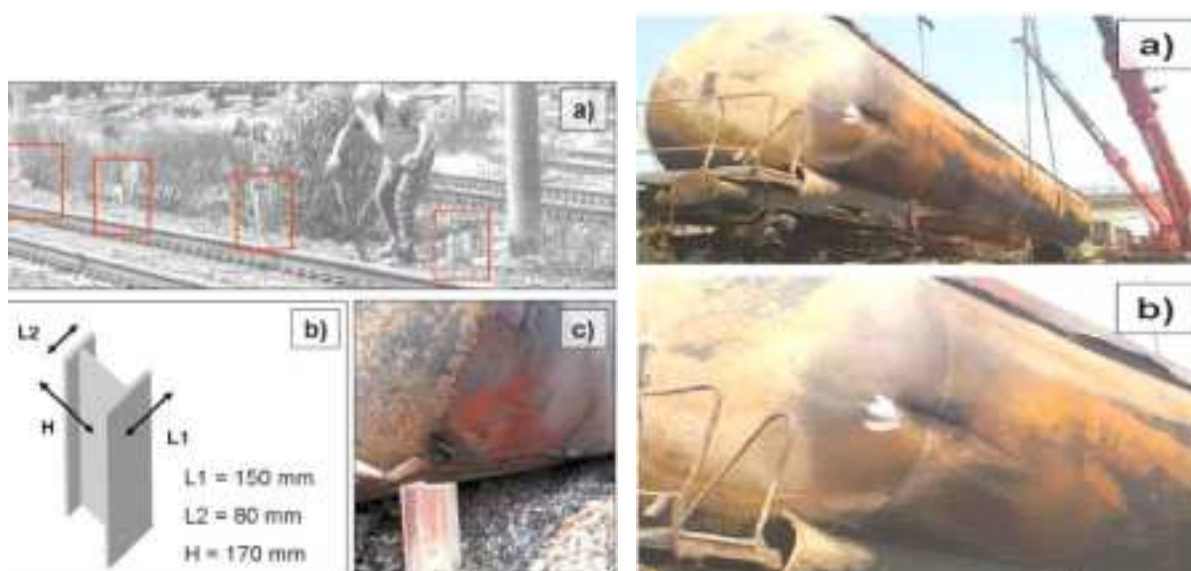
Fig. 7

- 3) A breach, about 40cm long and 2-5 cm wide (fig. 8) [4], was produced in the first rail tanker after the derailment. The cause of the breach is still under discussion, highly suspected are either the I-shaped stakes disposed close to the railway line (fig. 7) [4], used as references to control rail stability, or the "common crossing" (or "frog") of a rail switch [1].

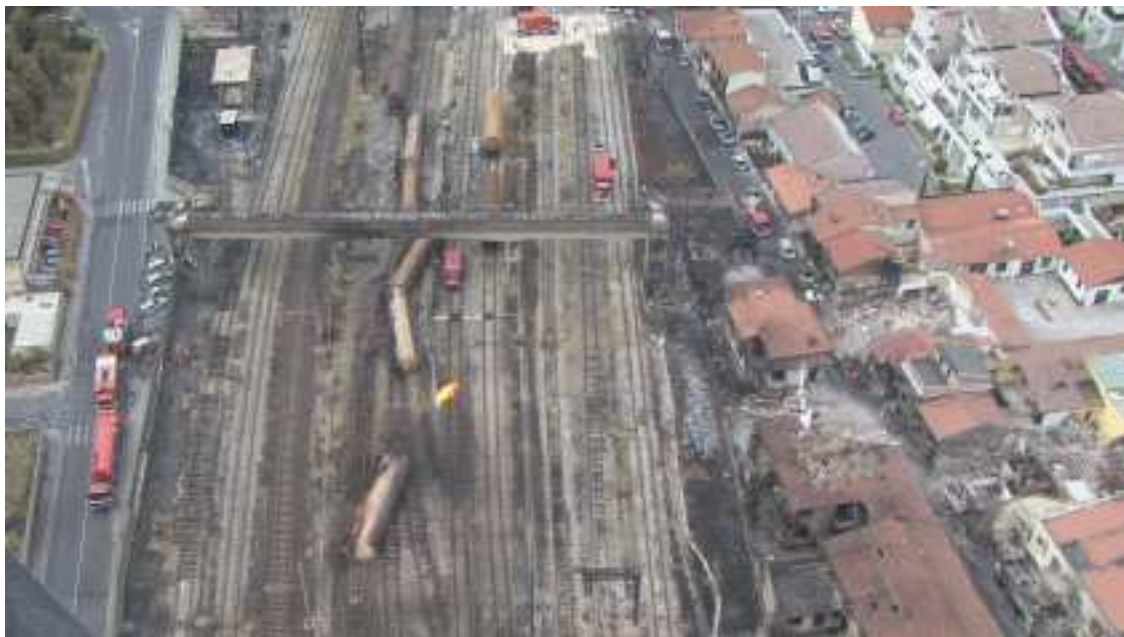
Fig. 9

The National Fire Emergency Centre immediately alerted and deployed the regional advanced CBRN (Chemical-Biologic-Radiological-Nuclear) units to the site in order to carry out the LPG transfer operations from derailed tankers to other tankers and allow its removal to a safe place. CBRN units from the provincial fire departments of Tuscany, as well as the Regional Advanced Unit of Tuscany, were called to the site to detect any trace of LPG gas and constantly monitor the derailed tankers. CBRN units from the provincial fire departments of Venice, Milan and Rome reached the incident site during June 30, to start preliminary operations – the setting up of special safety and gas transfer equipment and the deployment of fire teams in charge of ensuring support and assistance to operations (fig. 9) [3] [4]. From the morning of June 30 to the evening of July 2, working 24 hours a day with no interruptions, about 700 tons of LPG were transferred to a total of nine tank lorries [3] [4].
