Explosion of a sulphuric acid tank

4 August 2009

Gonfreville-l'Orcher

Chemistry
Sulphuric acid
Hydrogen
Explosion
Tank
Maintenance
Equipment defect
Organisation / controls

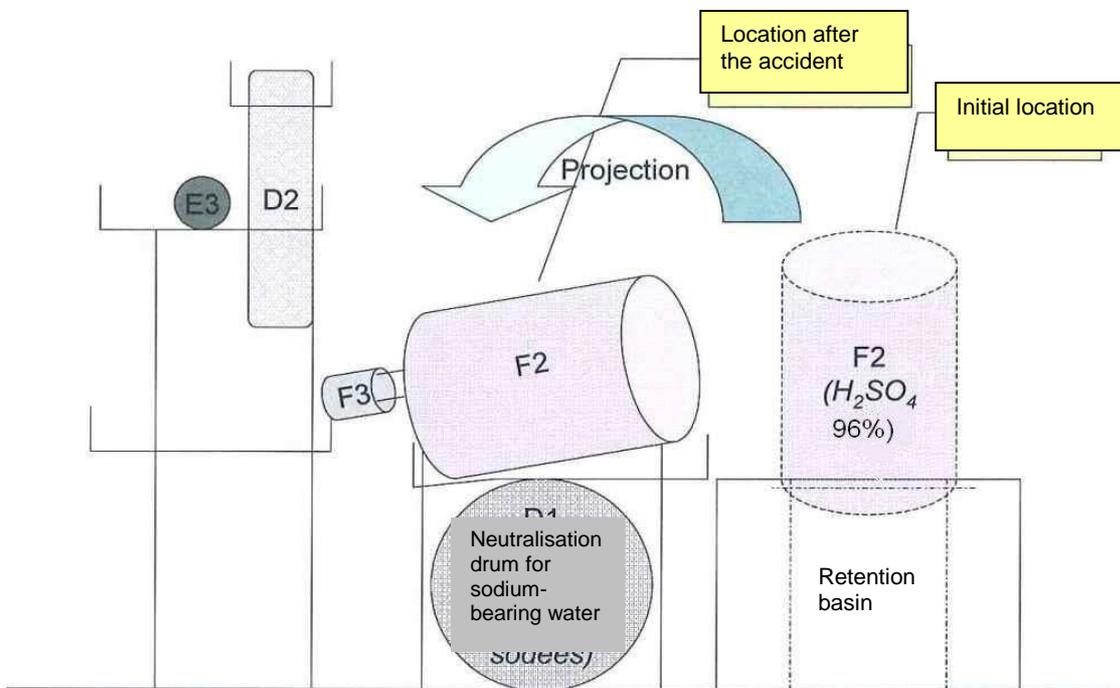
The accident occurred on a 100-m³ capacity tank (built in 1974) containing sulphuric acid concentrated to 96%. Installed outdoors on piles above a retention basin lined with epoxy resin and part of the unit for treating sodium-bearing water, this tank was used to supply :

This tank had already been repaired in 1989 following an incident that caused its delamination, yet without breaking any fastenings, due to a release of carbonic gas during the sulphuric acid neutralisation step (ARIA 23705). A support bracket had been added in response to this initial accident, and the cleaning procedure was also revised.
