Explosion of a truck carrying explosives

22 March 1989

**Peterborough
United Kingdom**

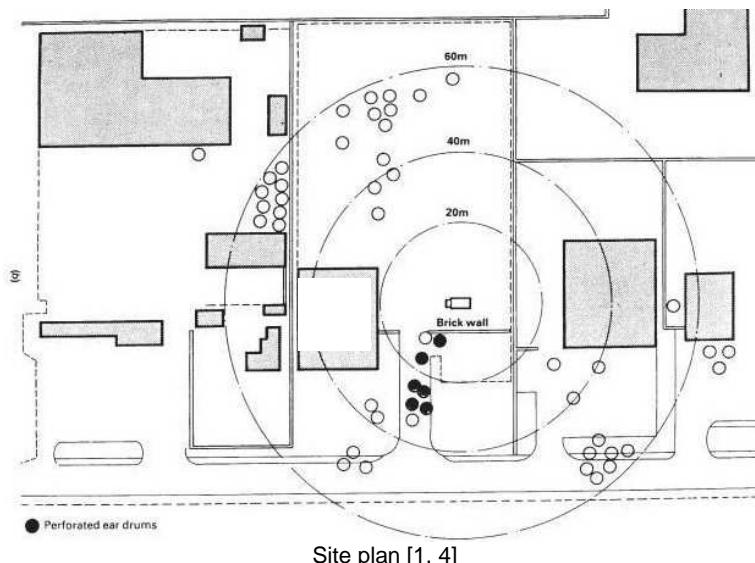
*Site plan [1, 4]*

The yard where the explosion occurred is on the edge of an industrial estate mainly comprising small to medium size commercial and industrial properties, consisting principally of large steel and pre-cast concrete framed buildings.

The entrance to the yard is set back and separated from the road by a pavement and grass verge some 24m wide: the yard is about 90 by 60 m, bounded on the south side by a 2 m high, 9" brick wall, and on the other sides by a chain link fence. The surface of the yard was asphalt over hard core. There was a 'sleeping policeman' speed ramp just inside the main gate.

As the vehicle entered the yard, it passed over the concrete speed ramp whereupon there was a minor explosion inside the load compartment which blew the rear roller shutter door outwards. As the driver continued in a clockwise circle around the yard he noticed in his rear mirror, blue smoke behind the lorry. He stopped the vehicle near the middle of the yard facing the exit.

One fireman was killed by a fragment as he was approximately 15 metres away from the burning vehicle., just beyond the edge of the wall on the south side and at the entrance to the yard and stood ready to receive water. A second fireman was badly injured (burns).
