Fire in a warehouse covered with photovoltaic panels

12th January, 2010

Val-de-Reuil (Eure)

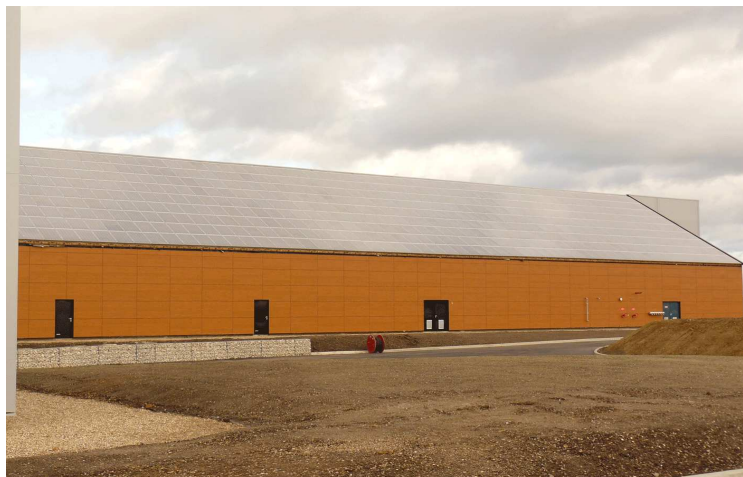
The industrial building and its roof composed of photovoltaic panels, prior to the accident - DR

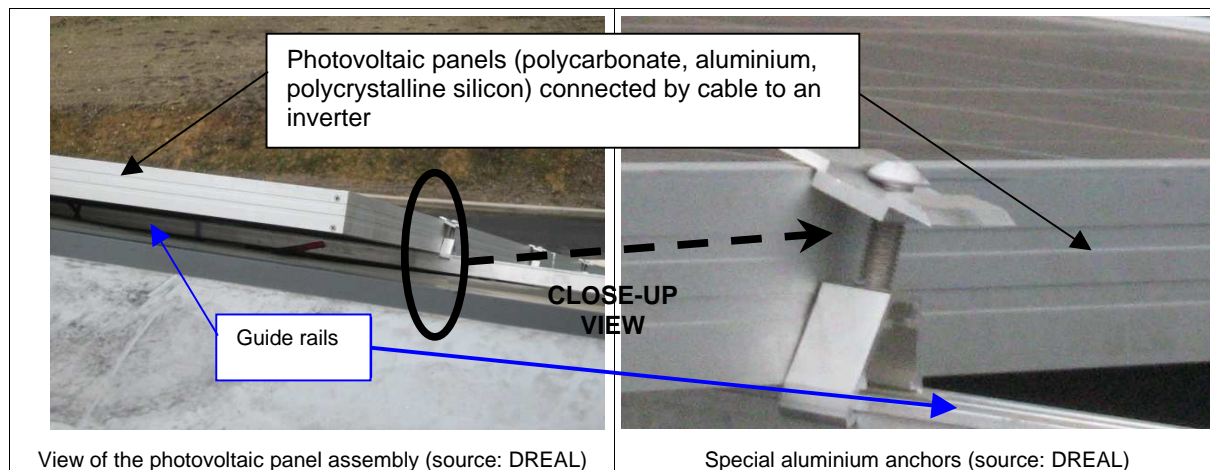
A layout embedded into the roof of the building streamlines the assembly of photovoltaic panels and allows for a perfect seal with the rest of the roof structure, via a system of guide rails and special anchors made of aluminium (see diagram on p. 2). This installation, at a price tag of €900,000, was able to output 132 MWh annually.
