## Explosion inside an underground storage of explosives

November 2, 1992

« Steingletscher », Swiss Alps  
 Switzerland

Pyrotechnics  
 Underground storage  
 Risk analysis  
 Waste  
 Ammunition

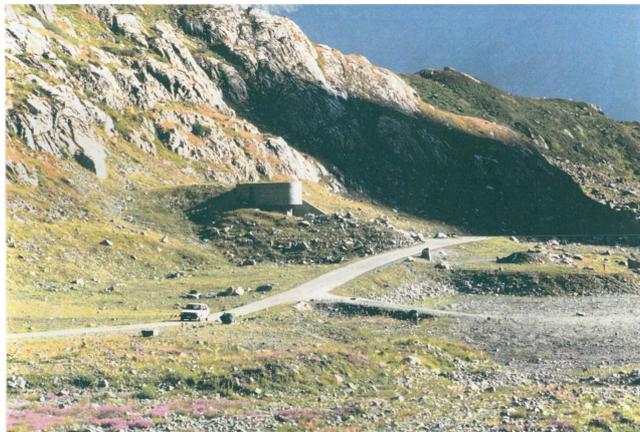
*Entrance of the underground storage and destruction area (before the explosion)*

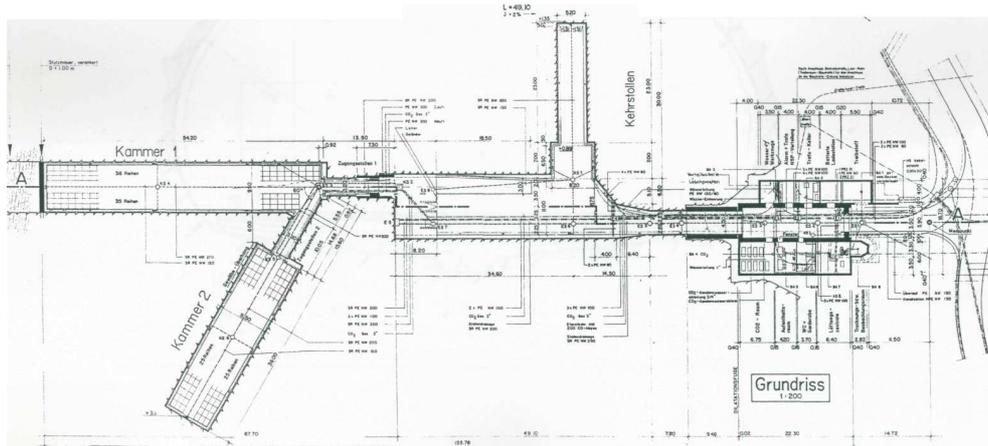
General layout of the underground magazine

Initially, the storage was supposed to be built as one 90 m-long chamber. During construction however, a geologically "bad zone" was reached after 60 m, which could not be crossed without enormous costs. It was therefore decided to seal the chamber with a concrete wall and to build the remaining part as a side tunnel.

The installation lay in very good rock, mostly granite. Therefore, the access tunnels and the chambers were not lined with reinforced concrete but were secured with shotcrete and rock anchors.
