# Explosion of a gunpowder factory

8<sup>th</sup> December, 1972

Muiden

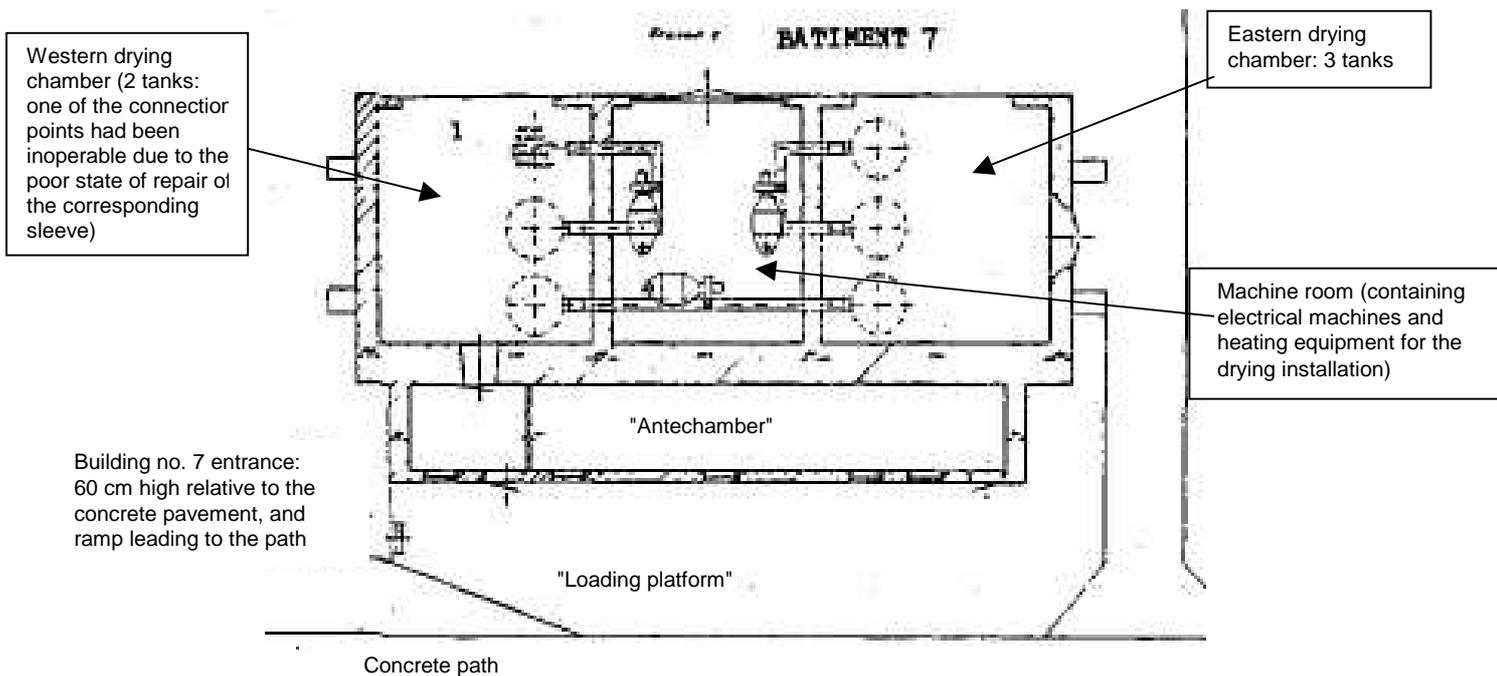
Built in breezeblock with a corrugated iron roof, the building was divided into 4 compartments by means of 55-cm thick walls:

An "antechamber" occupied nearly the entire building length (15 m long by 2 m wide). Separated from the remainder of the building by a 1-m thick wall, this antechamber had 2 points of access: an interior wood door from the western drying chamber, and an exterior door almost exactly opposite the first one, yet punctured into the building's southern facade.

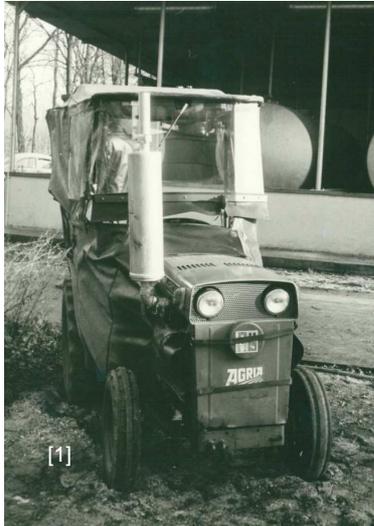
The drying tanks filled with gunpowder were transported between the various buildings by means of a platform truck running on solid tyres and drawn by a small tractor on tyres activated by a four-stroke, 16-horsepower diesel engine with air cooling (see opposite). The engine exhaust pipe and muffler were both turned upward, and moreover the exhaust was fitted with a fireguard. The forklifts were specially designed with features like: a smooth floor, shock-resistant edges, and dimensions for two tanks.

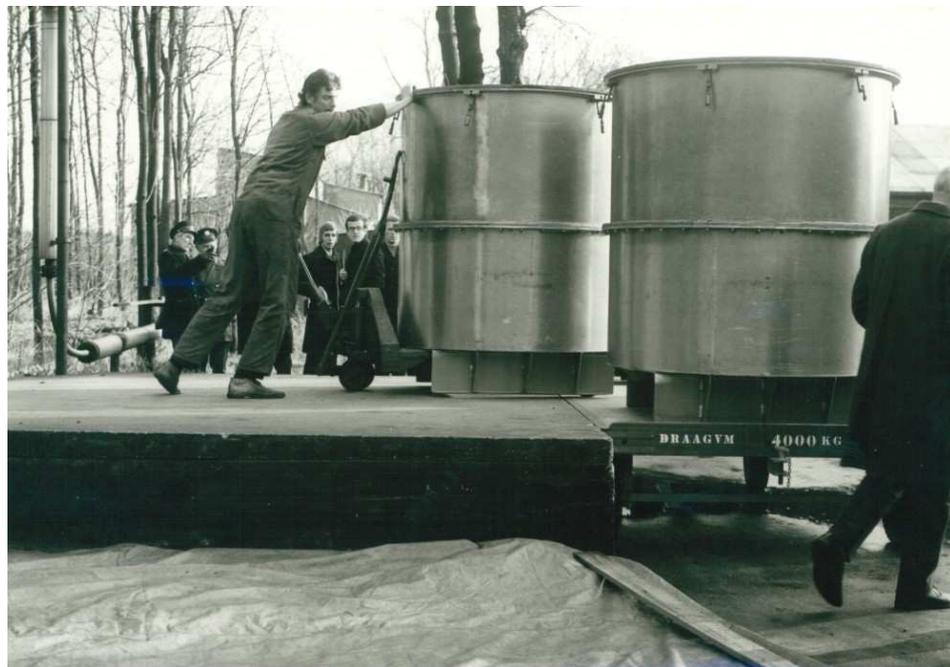
*Reconstitution of a tank trans-shipment operation using a small forklift truck [1]*
