Explosion and fire at a pesticide manufacturing plant

28 August 2008

Institute, West Virginia
United-States

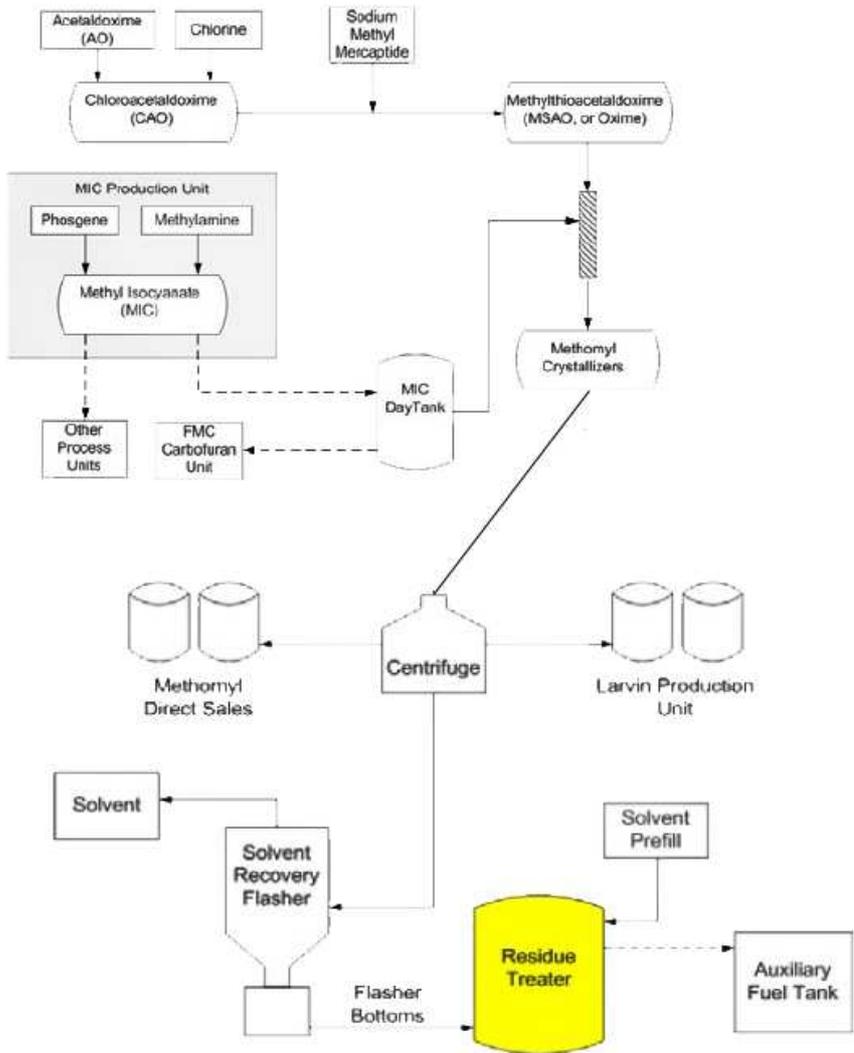
Old residue Treater / Picture CSB (R.R.)

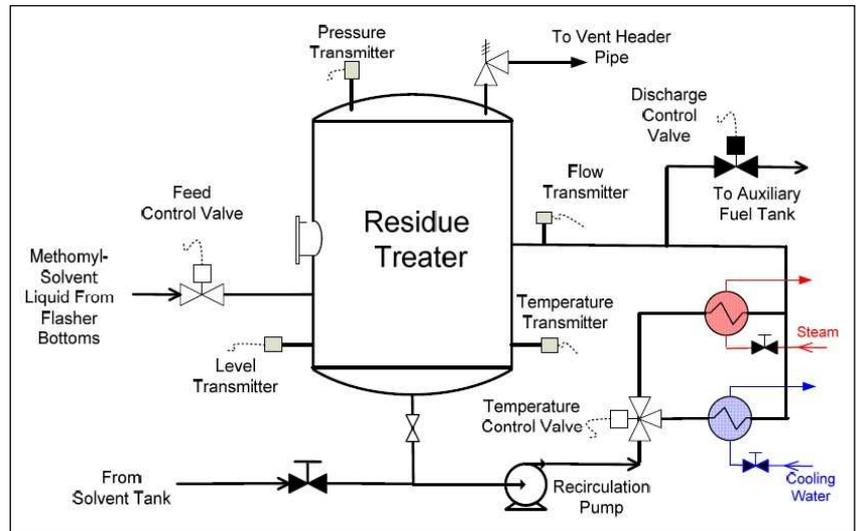
The operating procedure specifies that the waste tank vessel has to be prefilled to a level of 30% with “clean” solvent and heated before introducing residues coming from the solvent recovery flasher bottom ; this would dilute and heat the incoming residues, allowing an immediate start of the decomposition process rather than a dangerous accumulation of Methomyl. The procedure also specifies, in certain cases (when the temperatures drops below 130°C or during start-up...) to control the Methomyl concentration in the tank, as the risk of runaway reaction had been identified if the concentration topped 1,3%.

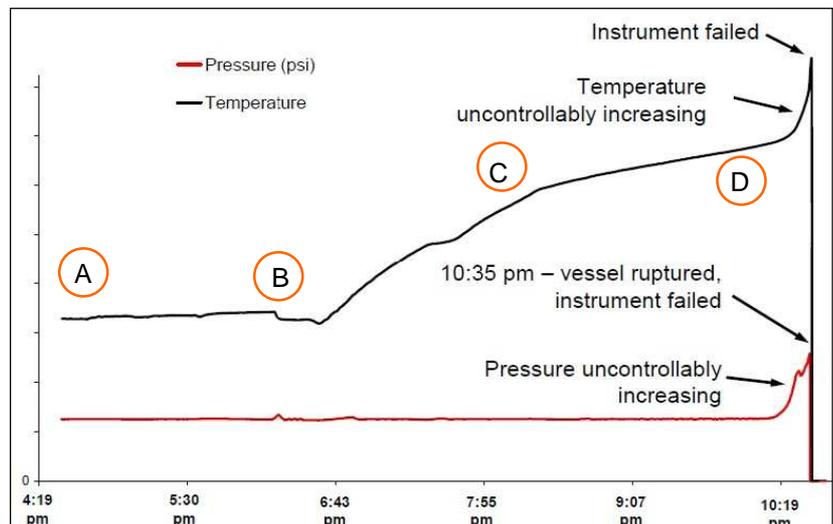
Adding to that, problems with the crystalliser led to significantly higher concentrations of Methomyl in the residues. The operators, facing difficulties with the centrifuge and crystallisers, did not review the lab results indicating a Methomyl concentration of 4 % in the liquid exiting the centrifuge and going to the solvent recovery flasher (8 times the specified

operating limit). As a consequence, the Methomyl concentration in the residues from the recovery flasher bottoms entering in the empty tank reached 40 % for a "normal" value of 22 %².

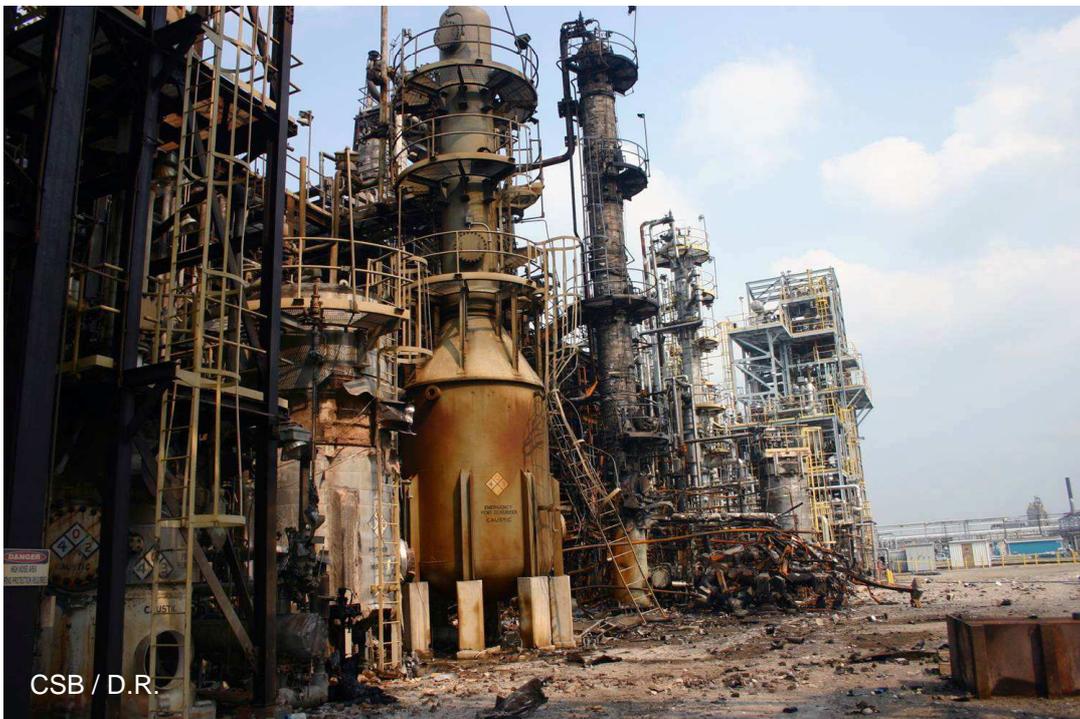
The residue treater severely damaged the unit (Picture CSB - R.R.)

Inside the factory, the blast overpressure moderately damaged the unit control building and other nearby structures. Debris was thrown some 50 m in all directions. Flying debris struck the protective steel shield blanket surrounding the MIC "day tank", but fortunately did not damage it, avoiding a toxic domino effect. The steel blanket also protected the MIC day tank from the radiant heat generated by the nearby fires that burned for more than 4 hours.

After the accident, the operator stopped the Methomyl production at the Institute facility. The operator also reduced the MIC storage by 80 %, eliminated all aboveground MIC storage and revised the MIC system Process Hazard Analysis.
