VCE in a waste treatment tank of a pharmaceutical plant

10 June 2010

Brindisi (Apulia)

Explosive atmosphere
Modifications
Hot work
Fermentation
Risk analysis

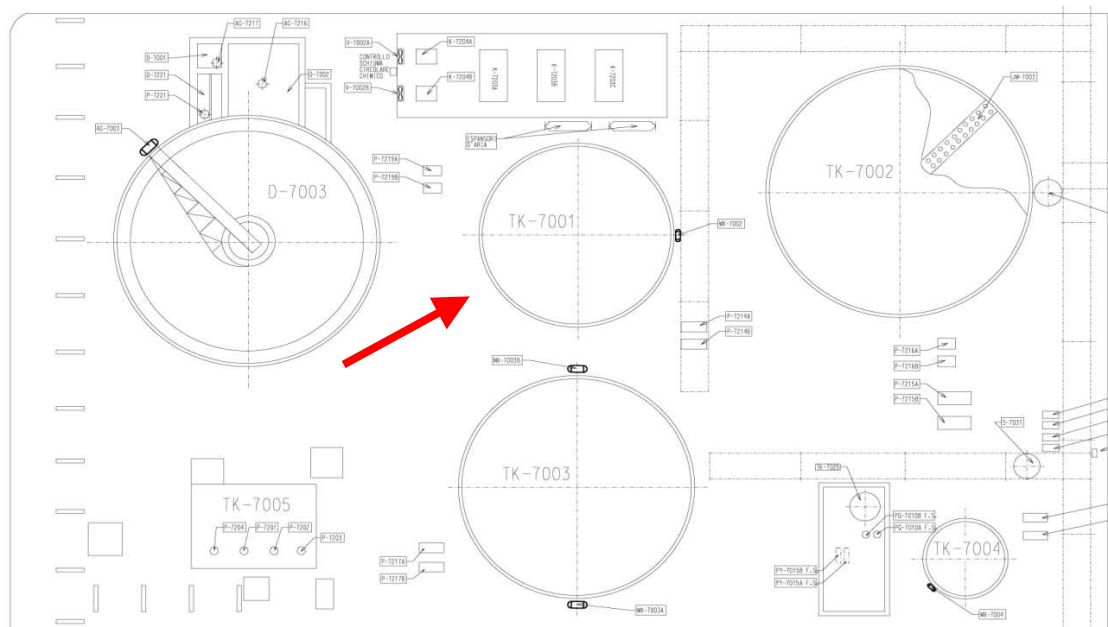
The waste treatment unit (Figure 2) is part of the principle O antibiotic production process, which is composed of the steps below:

Fig. 2: Waste treatment unit layout (source: operator)
